## Phase II Archaeological Testing and Historical Research for the SSSIC North Birmingham Furnaces Site (1Je808), Jefferson County, Alabama ALDOT Project HPP-1602(510) Jefferson County

by  
Catherine C. Meyer

November 9, 2016

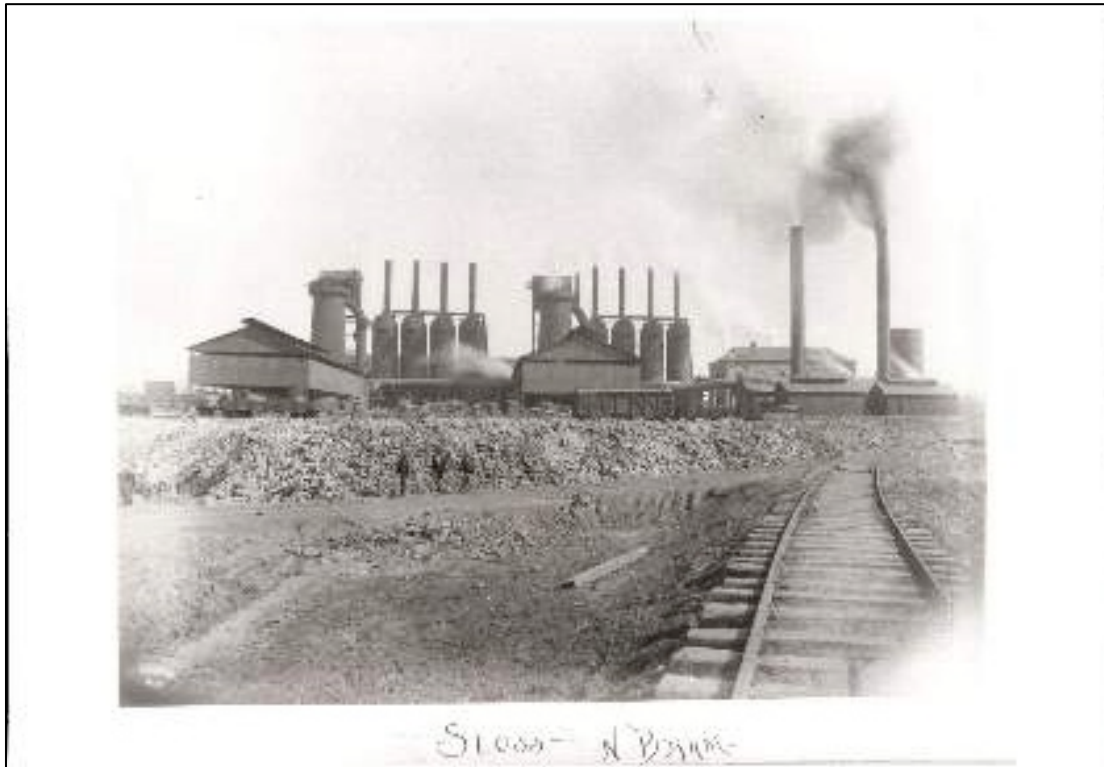
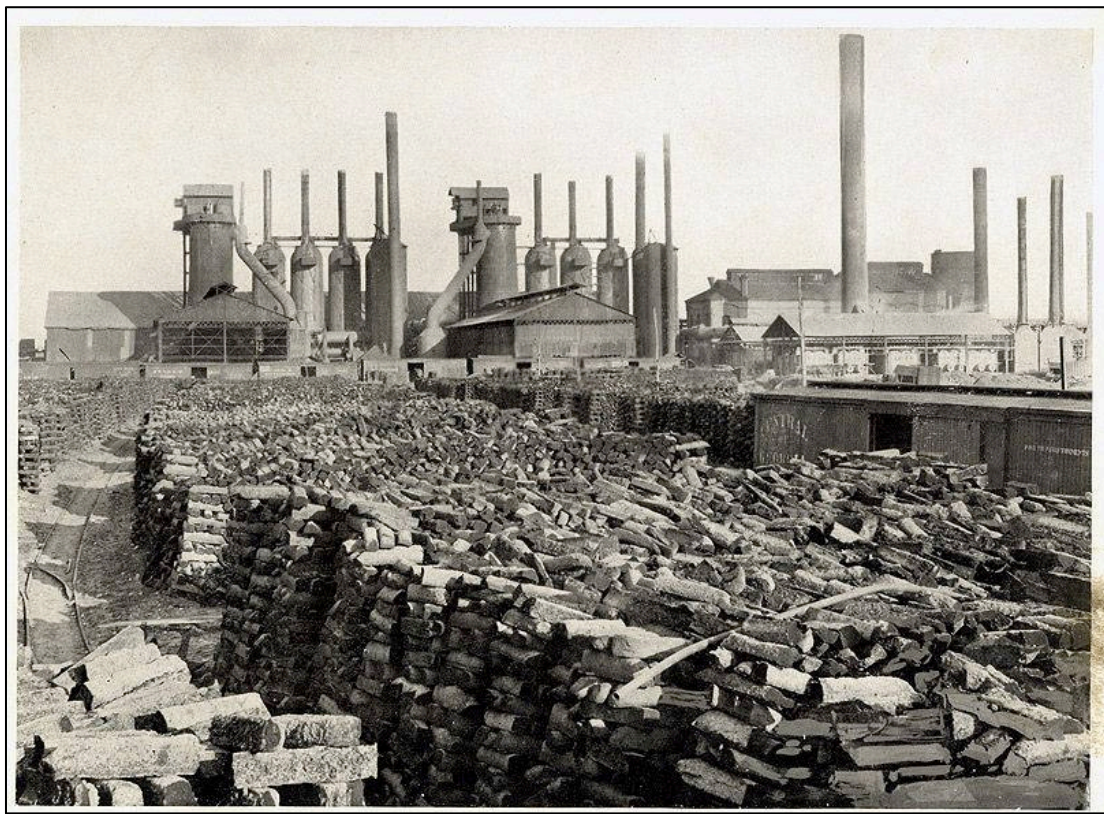
Figure 24. 1890s Photograph of the North Birmingham Furnaces (<http://www.alaironworks.com>).

Figure 25. 1908 photograph of the North Birmingham Furnaces (<http://www.bplonline.org>)

Comparing the 1890s and 1908 photographs (Figures 24-25), the rebuilding of the two blast furnaces included an at least partial, if not complete, replacement of the original Gordon Whitwell Cowper array of eight three-pass stoves with ten two-pass stoves. The later photograph depicts that these ten stoves were separated into two banks of four stoves, one bank of two stoves and two stand-alone stoves. One chimney is indicated with each four and two bank arrays. The two stand-alone stoves have adjacent chimneys.

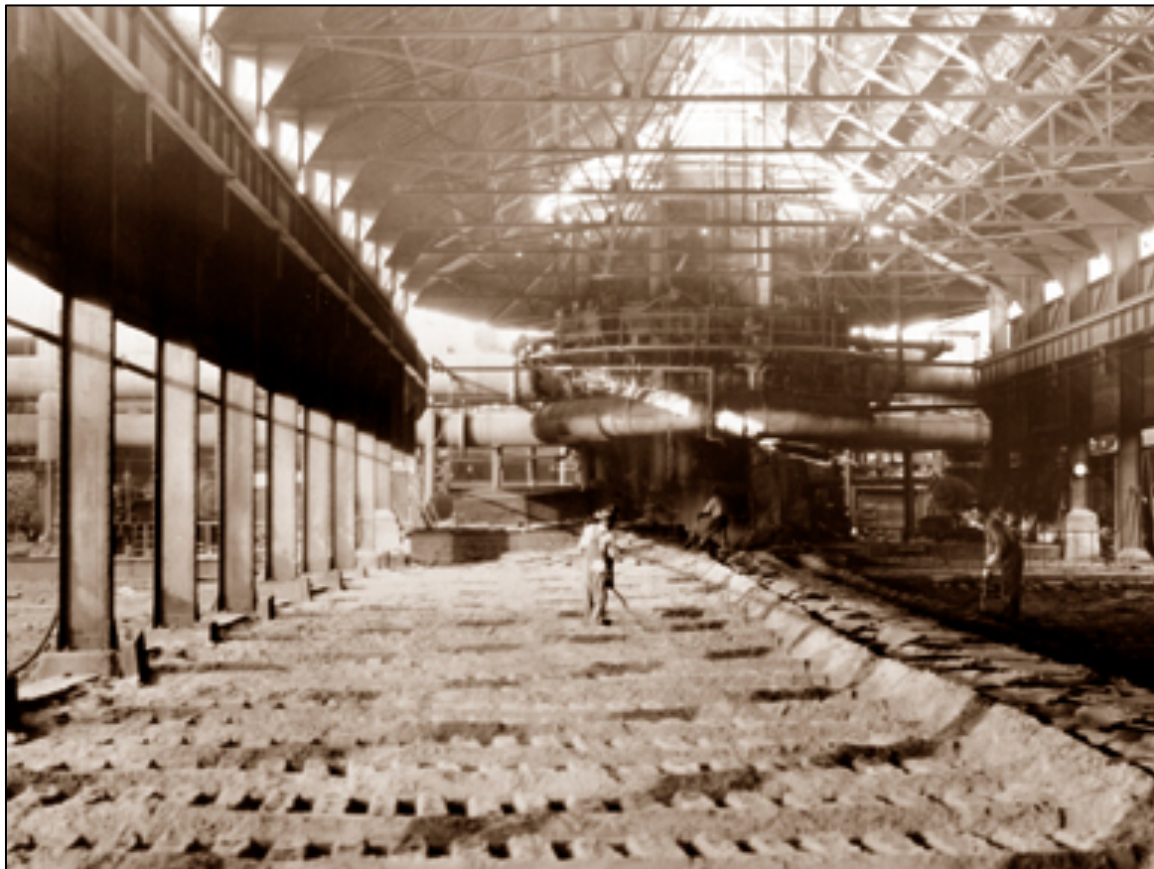
Figure 27. An Undated Photograph that Likely Dates to the Early 1900s Showing the Interior of What is Believed to be the No. 3 Casting Shed (<http://www.encyclopediaofalabama.org/article/m-4467>).

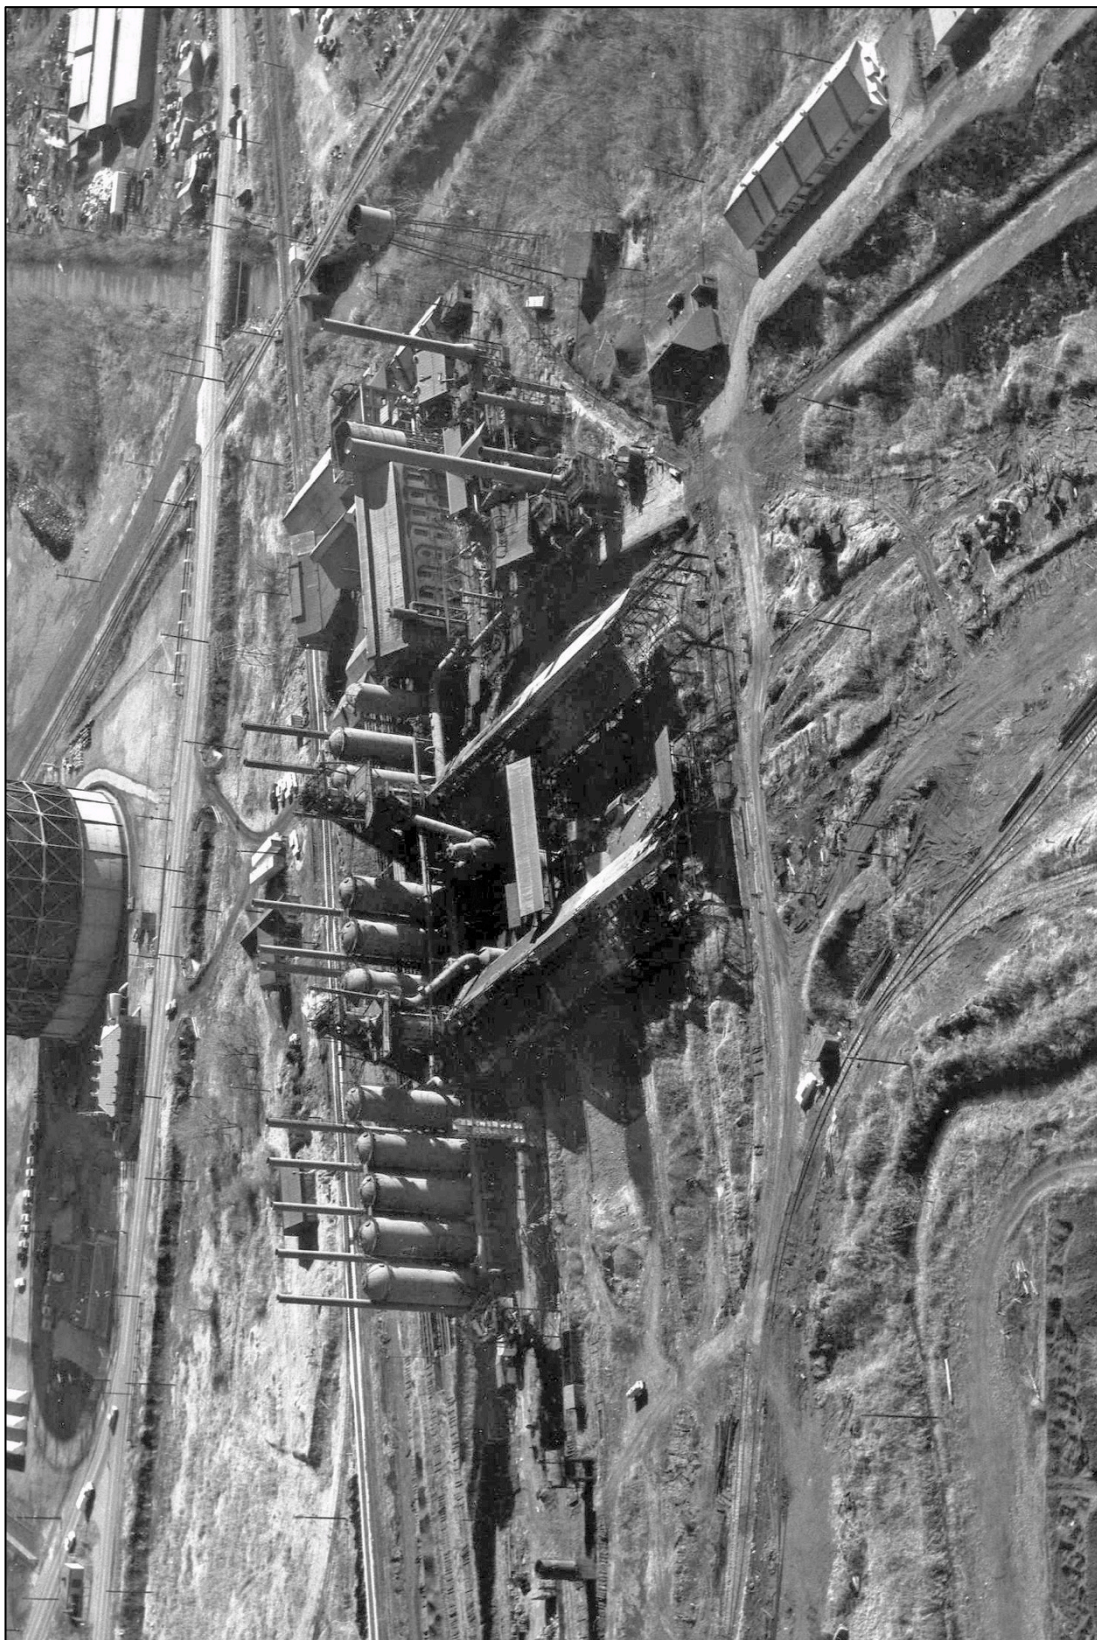
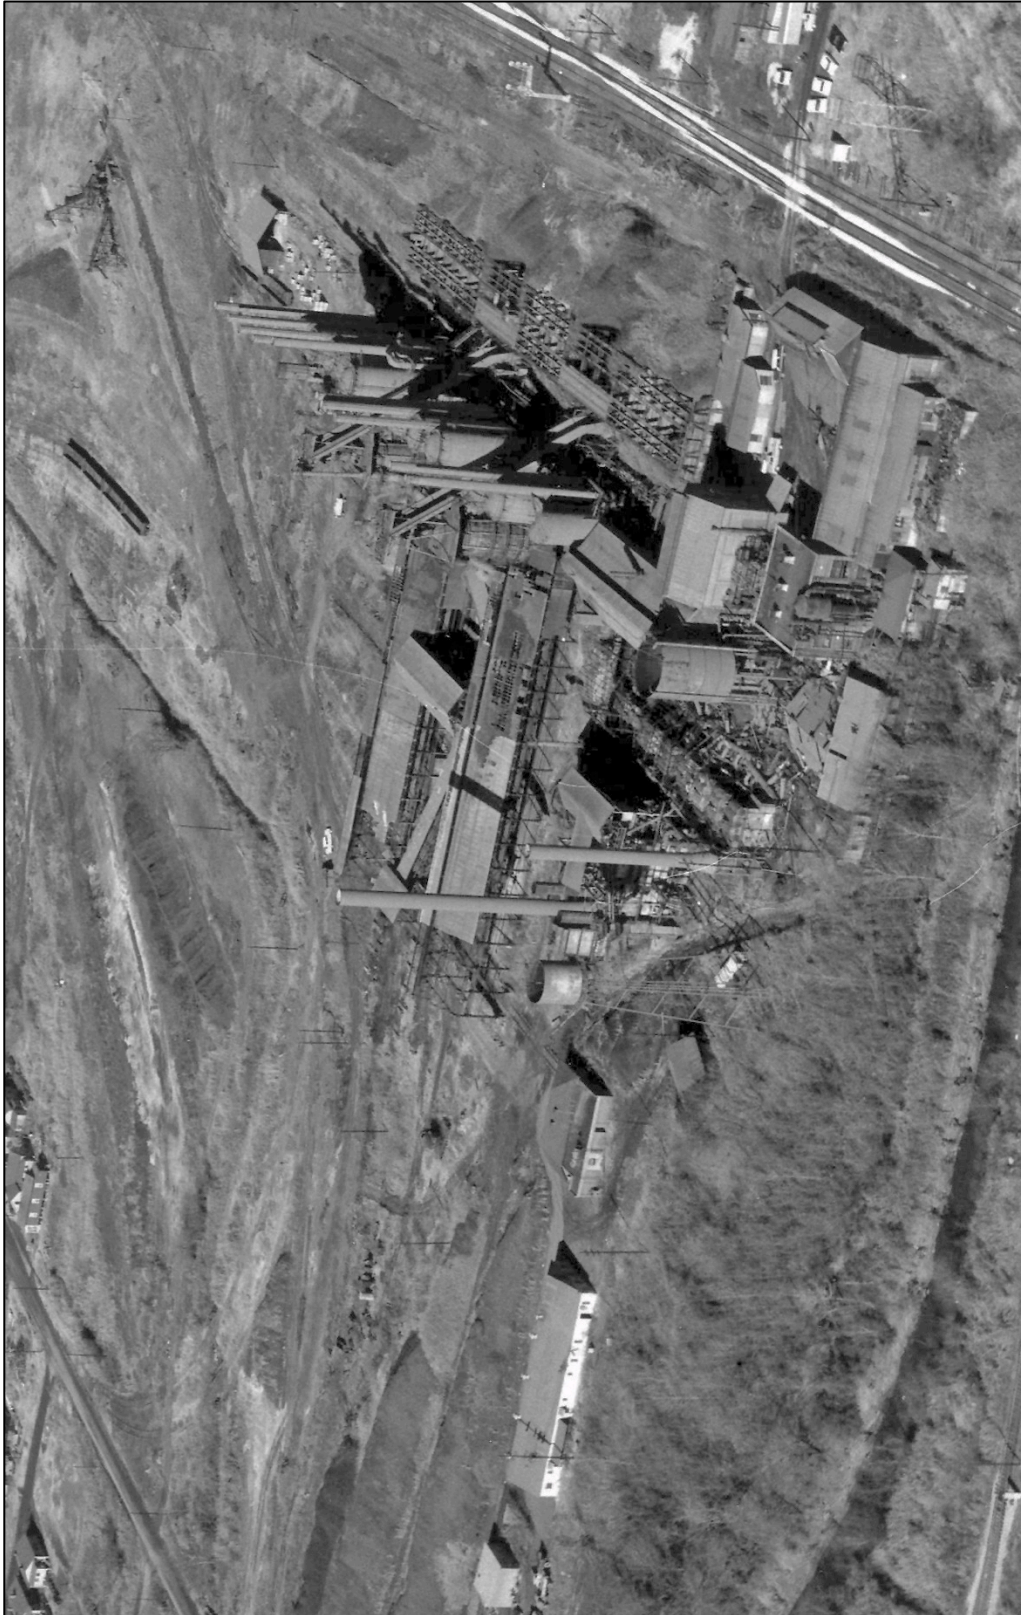
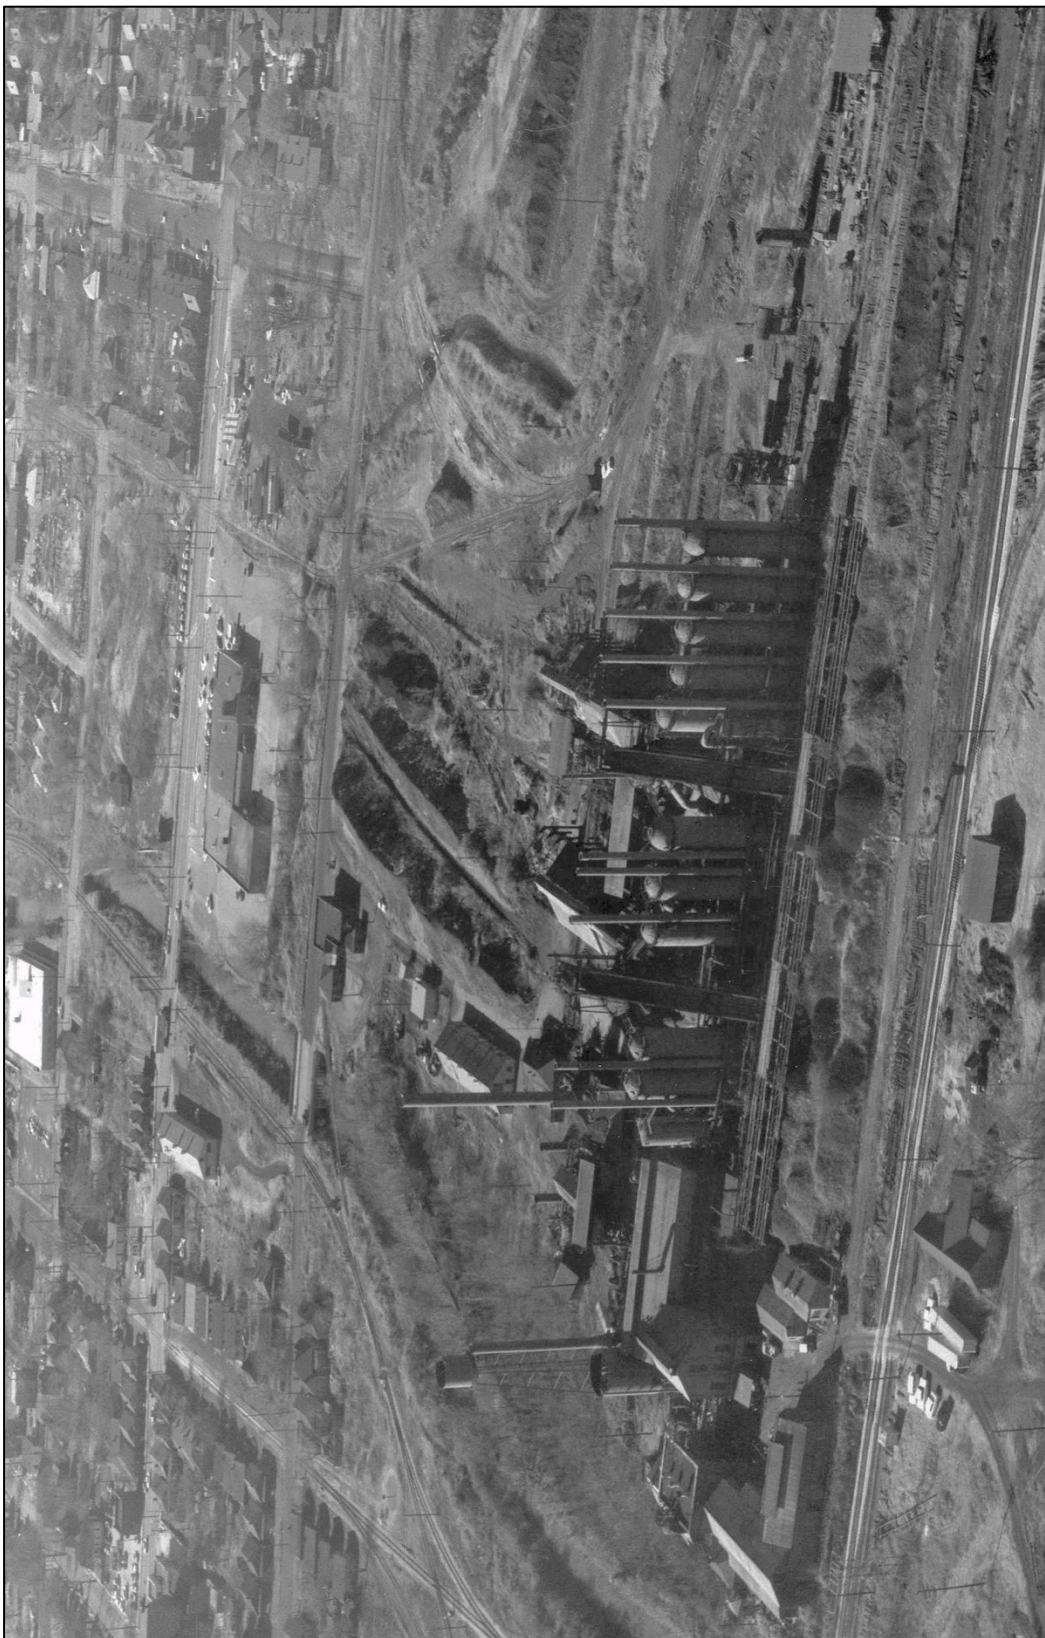
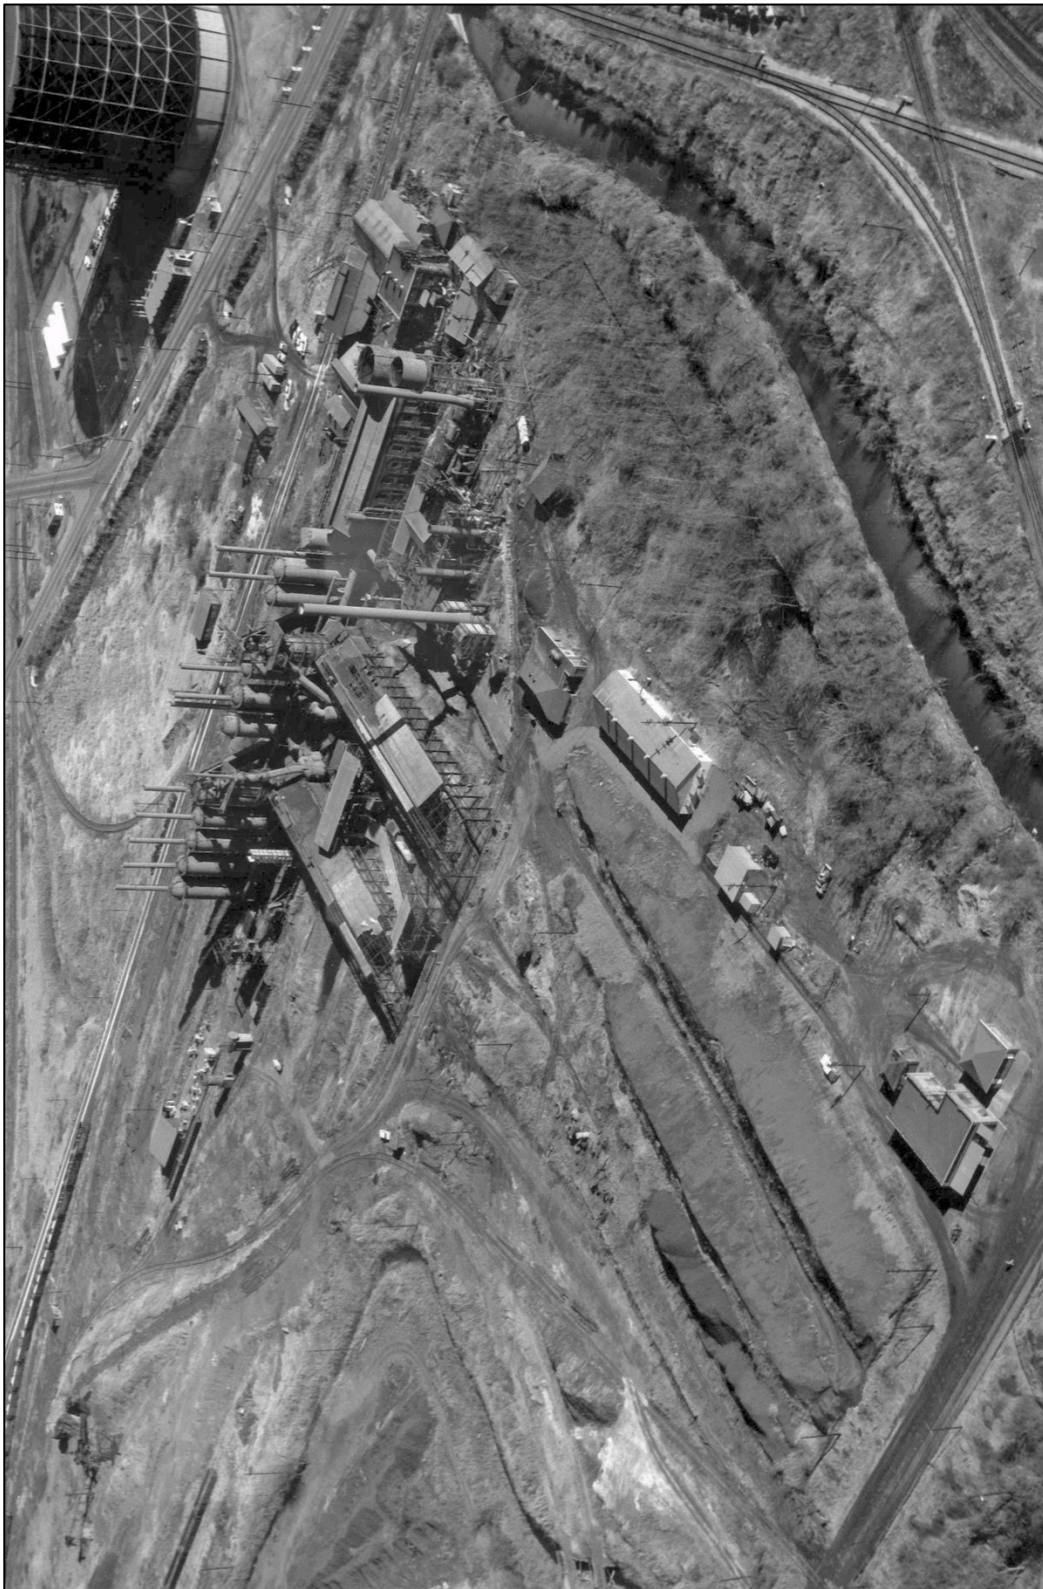
A set of four photographs (Figures 28-31) dating to 1964 was found in the BPL Department of Archives. These photographs appear to have been taken from an airplane at different vantage points around the facility. The facility was shut down around 1958. The 1964 photographs suggest that the facilities had been vacant for some time, based on the condition of some of the roofs. It is suspected that these photographs were taken shortly before the facility was dismantled by U.S. Pipe and Foundry Company, which merged with SSSIC in 1952. These photographs show how much the facility had changed since the early 1900s. These images correlate very well with the 1951 Sanborn map. The most notable features at the facility include: 1) two skip hoists have replaced the earlier vertical elevators; 2) the casting sheds are approximately twice the length of the original sheds, are on ground level, and are still constructed with metal frames and roofing (but the roofing is only partially intact); 3) two smaller sheds exist between the casting sheds, which are likely a ladle mixer shed and a pig casting machine shed; 4) the stock shed no longer exists, although a double, stock trestle is still

positioned behind (east) the furnaces; 5) the only sizable brick structures noted at the facility include the two-story engine house and two-story power house; 6) smaller brick structures existed to the southwest of the facility, including a bathhouse, the office/laboratory/ storeroom building, and possibly a company store; 7) two sets of boilers (called ovens on the 19541 Sanborn) are still contained within metal frame structures, but the metal roofs are no longer intact; 8) there are two elevated water tanks, which includes the large, metal water tank positioned behind the engine house; and 9) there is a slag granulator and storage shed on the north side of the facilities. It is notable that sizable stockyards filled with slag and/or spoil piles border the west and north sides of the facility. It is also noteworthy that the casting sheds are built at ground level and are not elevated or sloped, which is unlike the casting sheds at the Sloss Furnaces NHL. This may also suggest that the furnaces at the North Birmingham plant were built at ground level, unlike the furnaces at Sloss Furnaces NHL.

Figure 28. 1964 Photograph Showing the North Birmingham Furnaces, View to the Southeast (Source: Birmingham Public Library).

Figure 29. 1964 Photograph Showing the North Birmingham Furnaces, View to the North (*Source: Birmingham Public Library*).

Figure 30. 1964 Photograph Showing the North Birmingham Furnaces, View to the West (Source: Birmingham Public Library).

Figure 31. 1964 Photograph Showing the North Birmingham Furnaces, View to the East (Source: Birmingham Public Library).

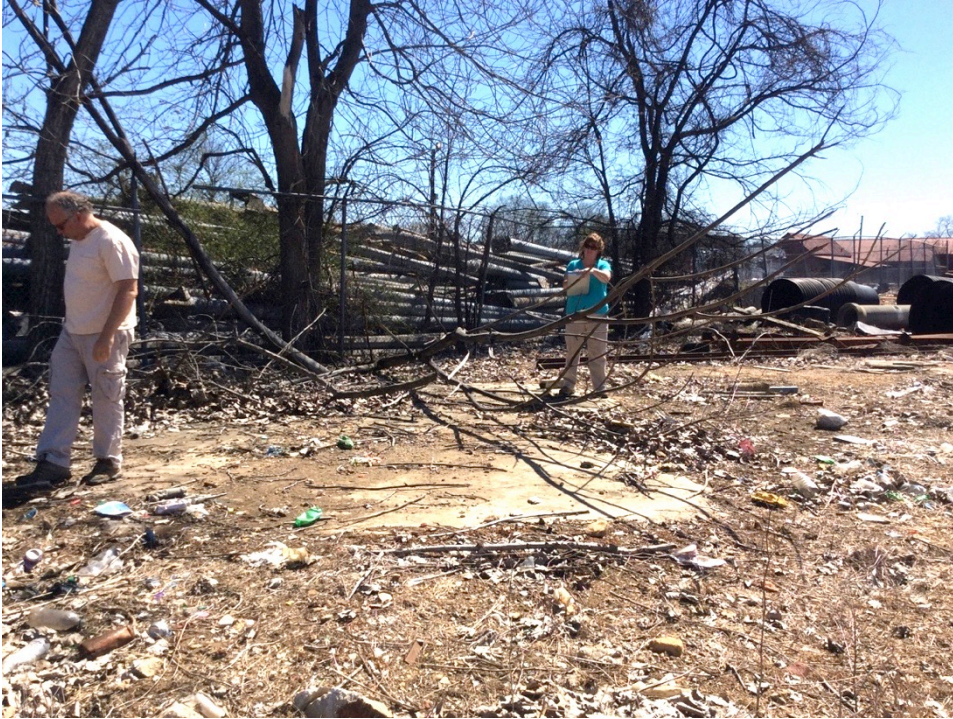
Figure 44. View to the Southeast of One of the Blast Stove Platforms Before the Refuse was Removed from the Gravel Parking Lot.

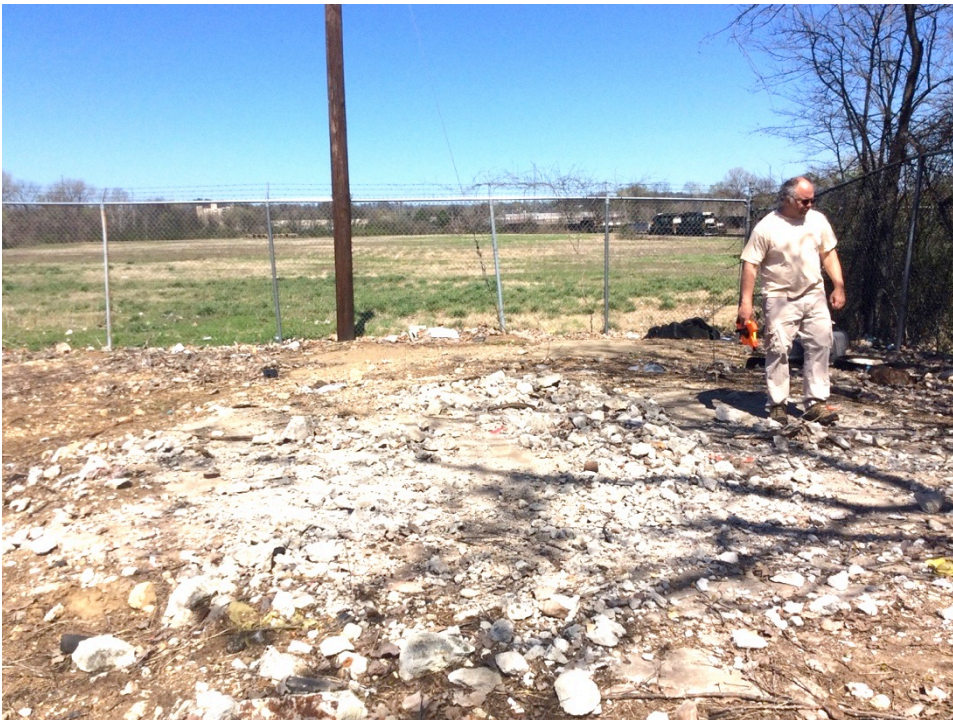
Figure 45. View to the North of One of the Blast Stove Platforms Before the Refuse was Removed from the Gravel Parking Lot.

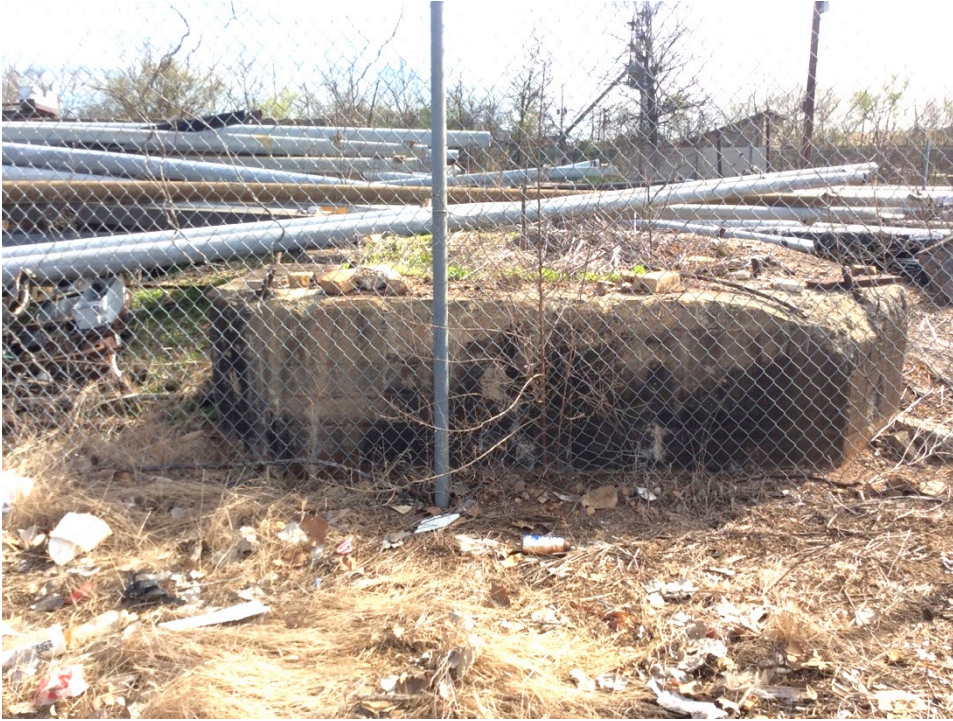
Figure 46. View to the East of Feature 16 Before the Fence and Light Poles were Removed from the Storage Yard.

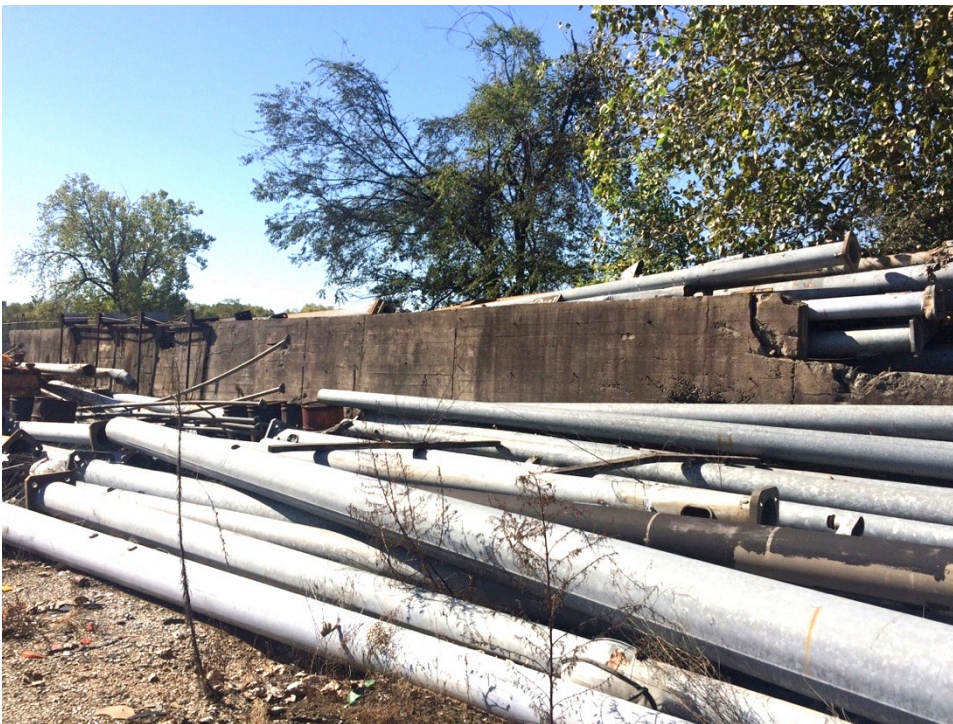
Figure 47a. View to the Southwest of Feature 17 Before the Light Poles were Removed from the Storage Yard.

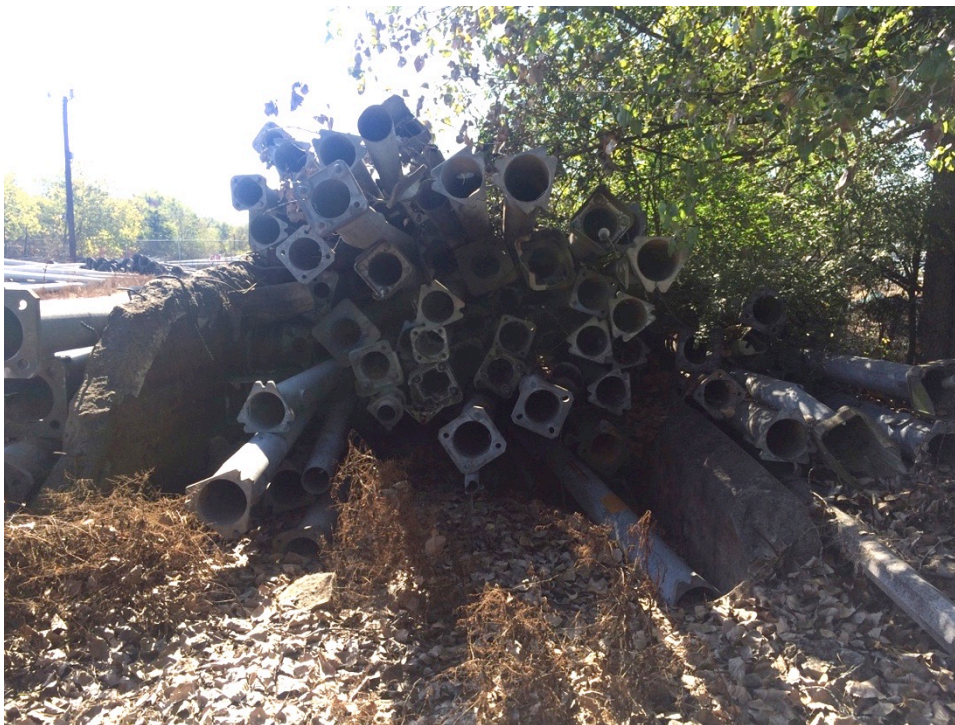
Figure 47b. View to the South of Feature 17 Before the Light Poles were Removed.

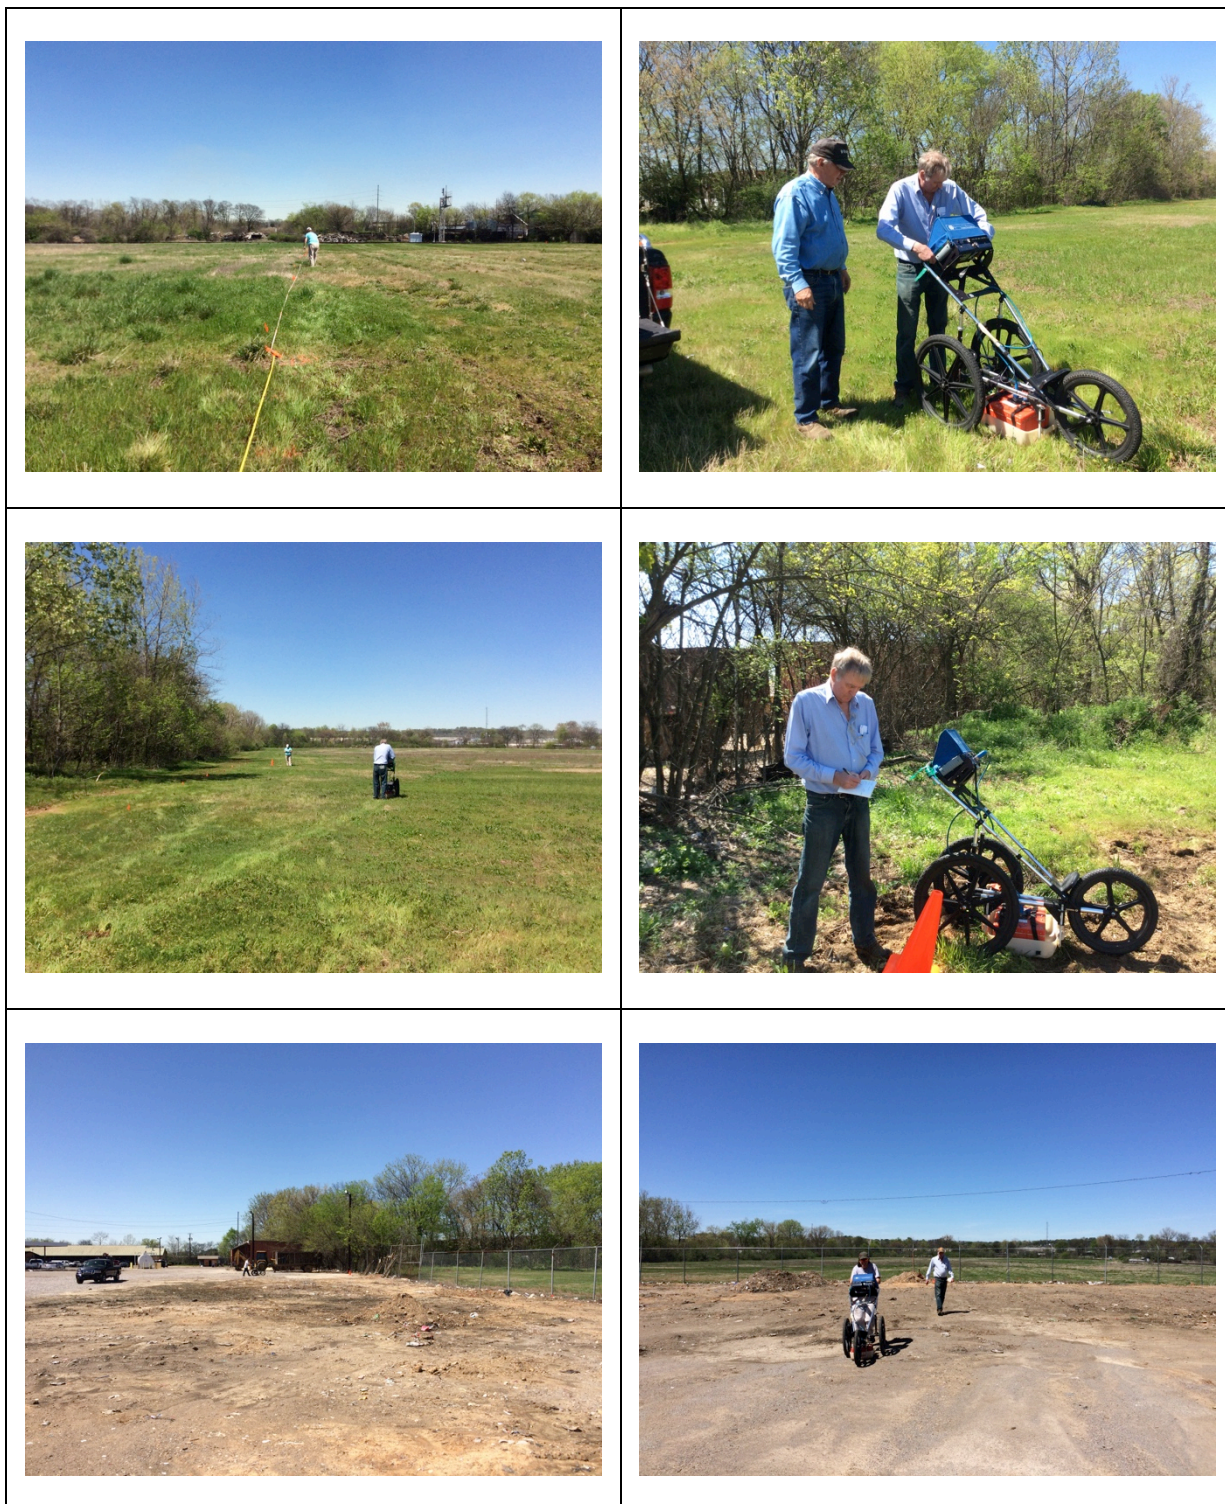
Kent A. Schneider and Douglas Luepke conducted the GPR survey for the project with the assistance of MRS (Figure 54). Their survey was conducted to determine if any intact subsurface features exist within the project ROW. Their investigation was restricted to the project ROW; however, they were unable to include the storage yard where the massive light poles and other materials were stored because the City of Birmingham was unable to move the materials within the project's allotted schedule. Schneider and Luepke's (2005) report is contained within Appendix A.

Figure 54. Photographs of the GPR Survey.

Schneider utilized an encoder-equipped cart-mounted GSSI SIR3000 digital control unit and a 400MHz antenna to collect the data. The time window was set to 50ns after test runs to observe signal attenuation and optimum penetration depth for the features sought. Radar profiles were acquired in forward and reverse directions on alternate lines. Measuring tapes were pulled to guide antenna travel and to make survey notes. GPR data was collected along the profile traverses at 40 scans per meter. A total of 8213 linear meters (26,945.5 ft) was surveyed. Data was post processed using GPR-Slice software. The radar data was composited into 20 amplitude slice maps to depths of approximately 2.19 m (7.2 ft). Two GPR maps were selected for data presentation, which are found in their report (Appendix A). Figure 55 provides the processed data overlaid atop an aerial photograph.

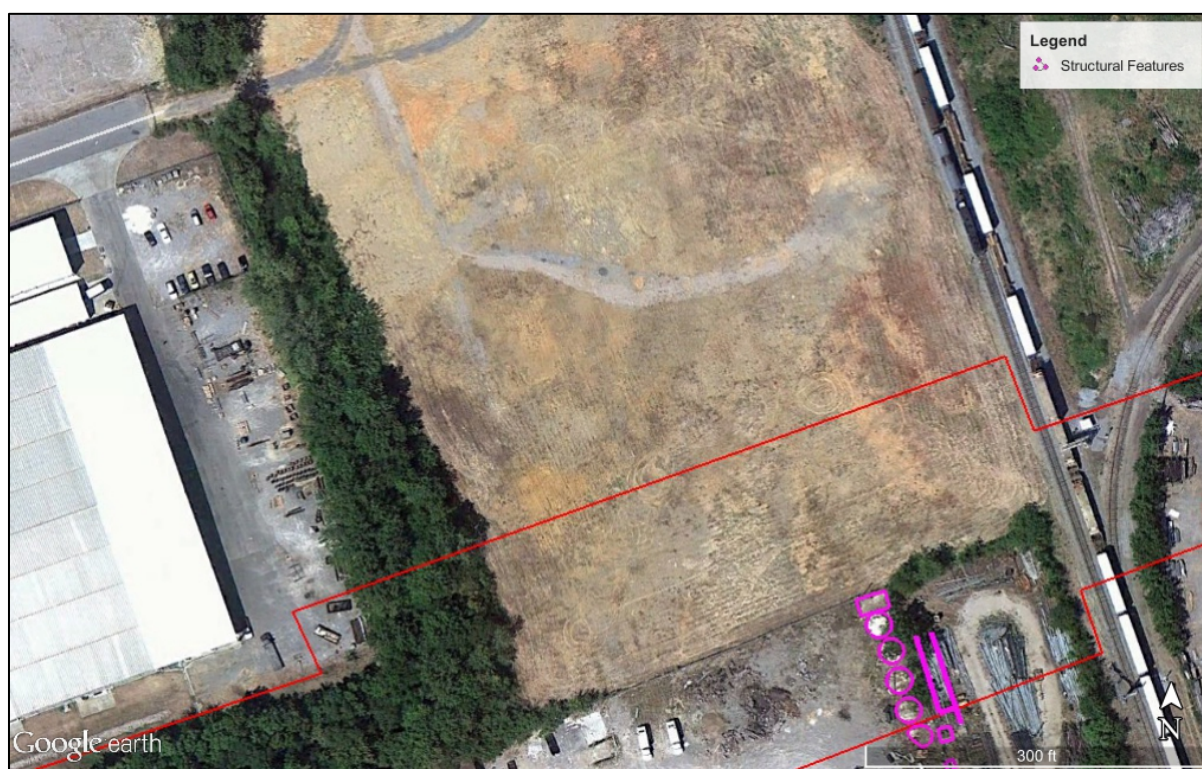
Figure 56. 2011 Aerial Photograph.

cleared in the mid 1960s when the facility was dismantled. The gravel parking lot was present by the early 1980s. Recent aerials indicate that the grassed field was cleared, filled, and bulldozed between 2009 and 2011 (Figure 56). In fact, some of the anomalies appear to be related to soil disturbances and fill materials that can be seen on these aerial photographs. Considering the fact that the facility was dismantled in the mid 1960s, then underwent mechanical disturbances over the next few decades, and was bulldozed and filled within the past few years, it was concluded that the anomalies identified by the GPR survey were unlikely to be associated with any intact structural remains associated with the SSSIC North Birmingham facilities. They are more likely to be associated with filling activities that have occurred within the recent past.

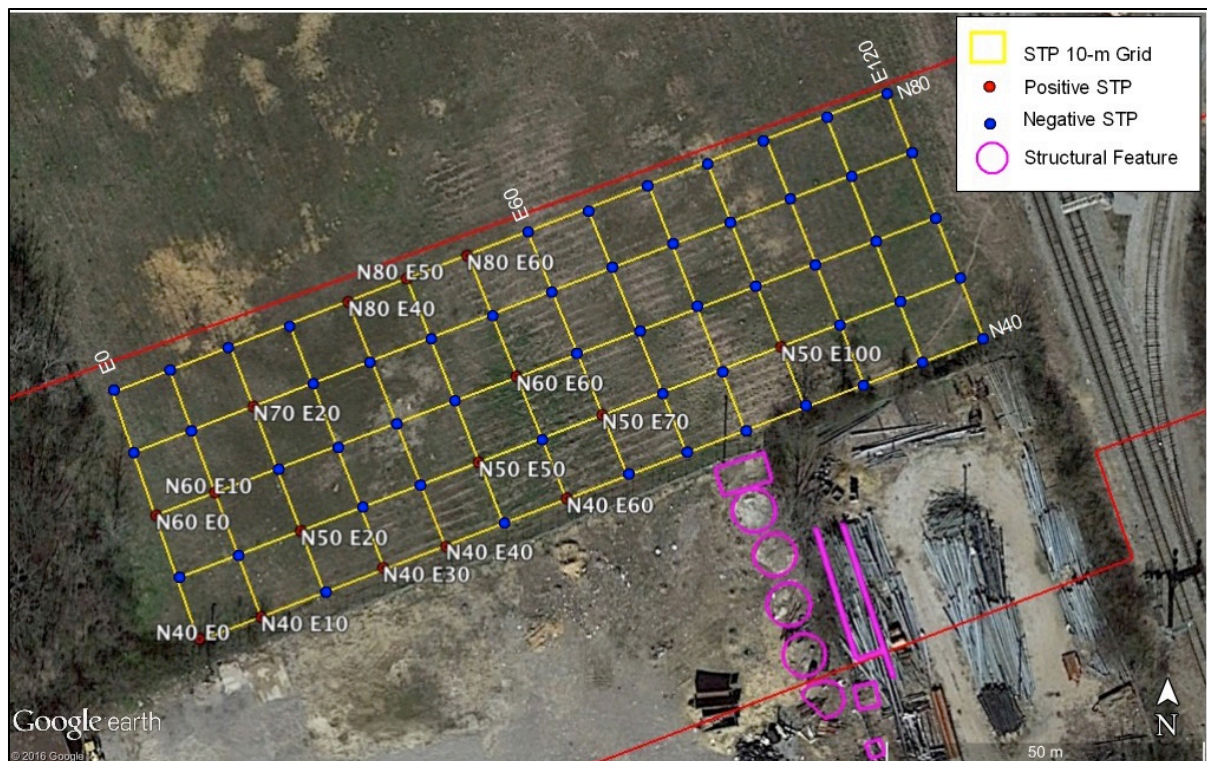
Jeffery M. Meyer and Catherine C. Meyer completed the shovel-testing program within two days. The North Grid that was laid out by UIS for the GPR survey (Schneider and Luepke 2005) was utilized for the shovel-testing program. A total of 70 shovel test pits (STPs) were excavated along the grid at 10-m intervals (Figure 57). All of the shovel tests were fairly shallow due to the disturbed, often compact, and mottled soil matrixes. Soil strata varied across the site, which appears to be the result of recent dumping of various materials within the field, as well as the historic use of the area for storing large berms of materials and spoil piles. Limestone gravel was often intermixed with the clay loam soils, most of which appeared to be modern fill material; however, some of the gravel fragments could be dolomite that was stored in the stockyards to use in the furnaces. Gravel from the STPS was not collected. Nine of the STPs were No Digs because the shovel could not penetrate into the ground due to a compact layer of fill. Slag was noted in or collected from many of the STPs. Two shovel tests, STP N80 E0 and STP N40 E10, contained a dark brown to black layer of industrial fill, which likely is associated with a remnant of one of the industrial stockpiles. Table 3 contains the stratigraphy for each STP.

Figure 57. Shovel Test Grid Map.

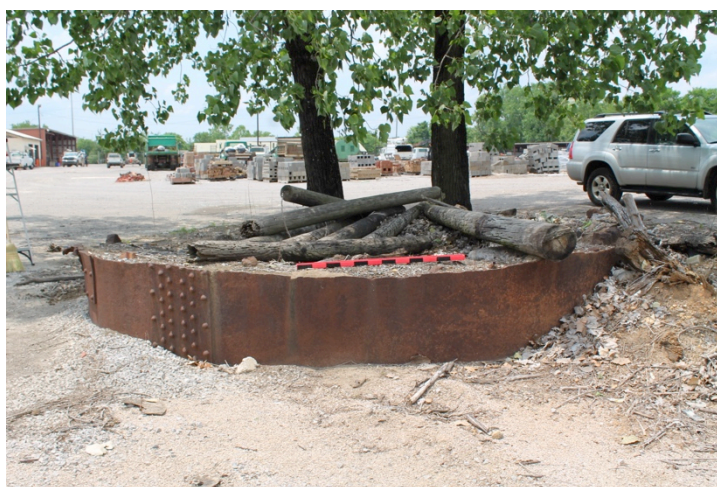
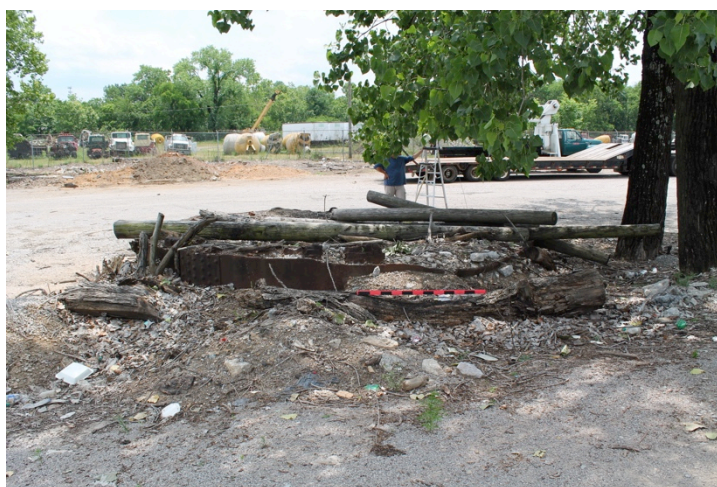
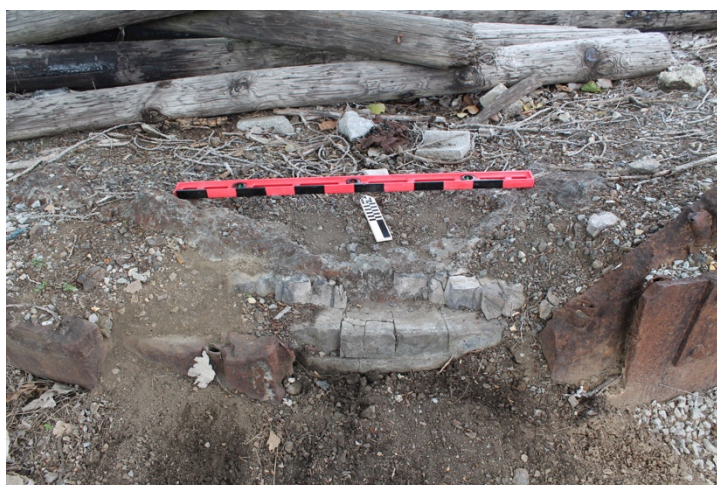
Figure 59. Feature 1, Remains of the No. 3 Furnace.

*West-Southwest View*

*South-Southeast View*

*North-Northeast View Showing the Interior Hearth*

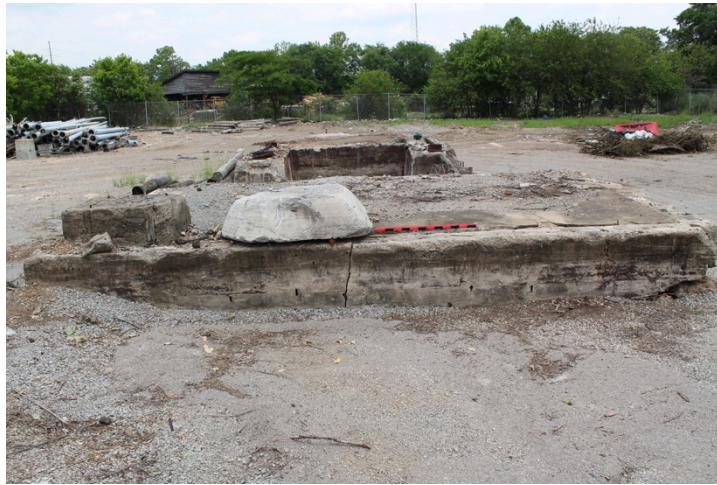
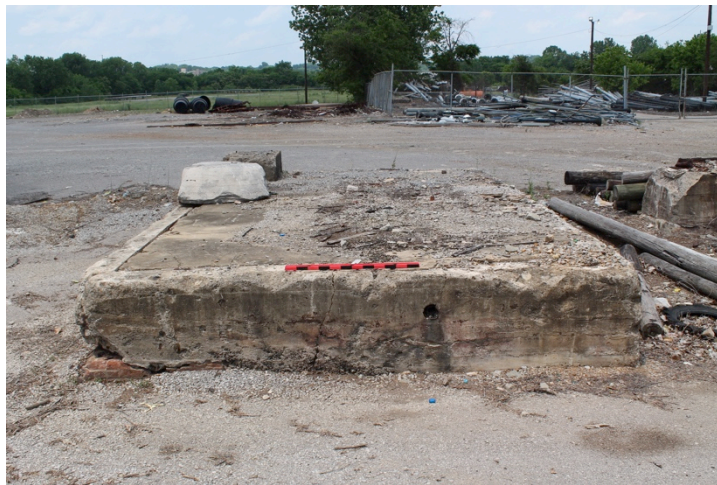
Figure 60. Feature 2, Foundation of Skip Hoist Engine House.

**General Description:** Feature 2 (Figure 60) is a rectangle-shaped, poured concrete foundation that sits between Feature 1 and Feature 3. This feature is positioned approximately 7.6 m to the east of Feature 1 (No. 3 Furnace) and approximately 3.1 m west of Feature 3 (skip hoist foundation). A small rectangular platform (measuring approximately 133 cm wide x 94 cm long x 50 cm tall) exists on top of the northwest corner of the foundation. Another molded piece of poured concrete sits atop the platform, which is not attached to the feature and may have been placed here more recently.

*East-Northeast View*

*North-Northwest View*

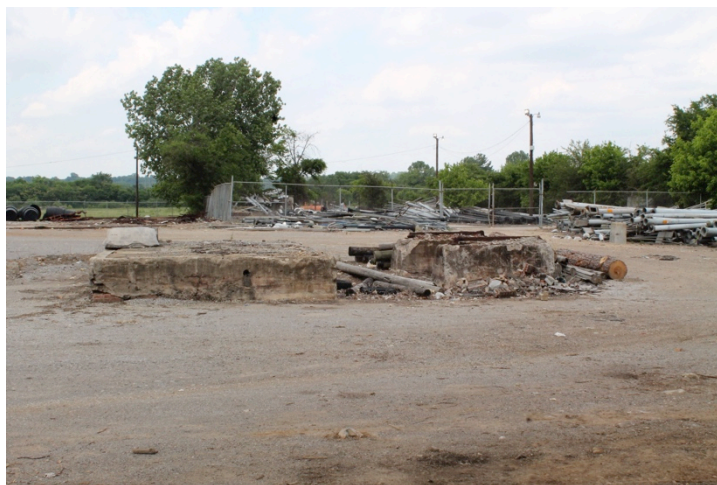
*North-Northwest View of Feature 2 (left) and Feature 3 (right)*

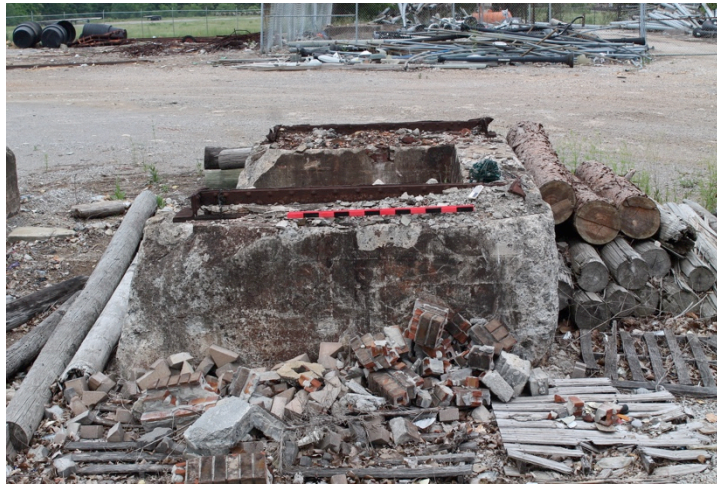
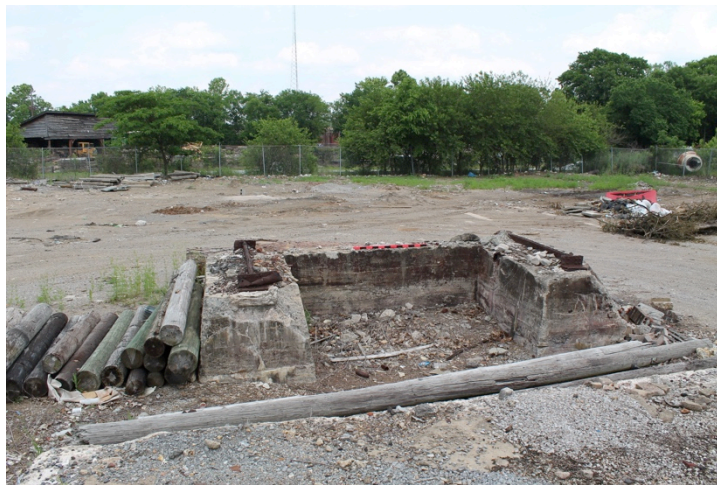
Figure 61. Feature 3, Skip Hoist Foundation.

*North-Northwest View*

*East-Northeast View*

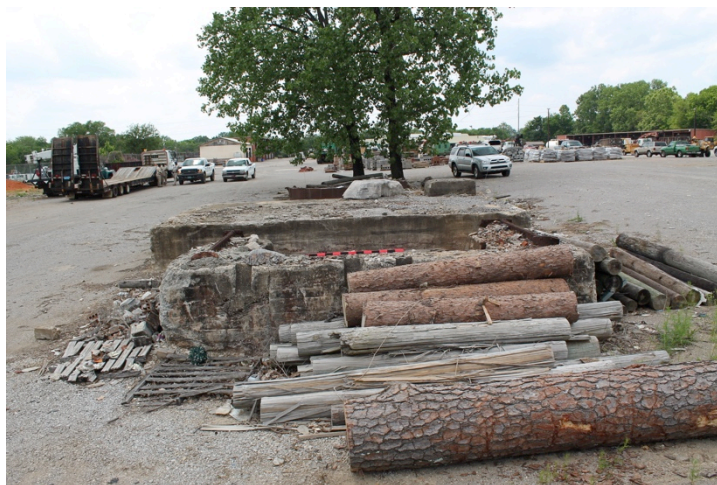
*West-Southwest View of Feature 3 (foreground), Feature 2 (middle), and Feature 1 (background)*

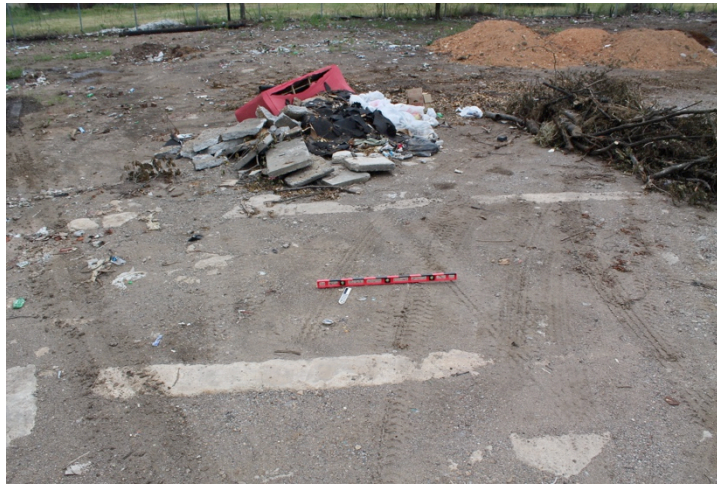
Figure 62. Feature 4, Suspected Remains of Stock Bins.

**General Description:** Feature 4 (Figure 62) consists of two linear, poured concrete features that are situated on the ground surface (just below the gravel layer). These features were not uncovered to any extent because they are situated outside of the project ROW, and they sit in an area where the sanitation department empties their street cleaners and vacuum trucks. The linear features are parallel to each other, and measure approximately 2.7 m apart.

*South-Southeast View*
