## Phase II Archaeological Testing and Historical Research for the SSSIC North Birmingham Furnaces Site (1Je808), Jefferson County, Alabama ALDOT Project HPP-1602(510) Jefferson County

by  
Catherine C. Meyer

November 9, 2016

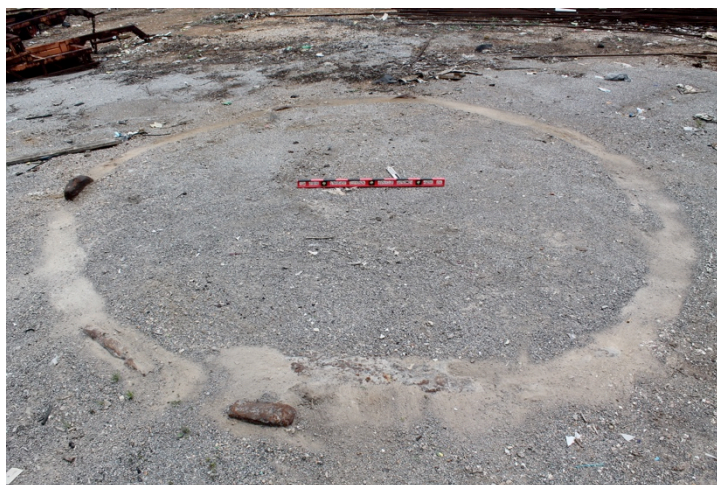
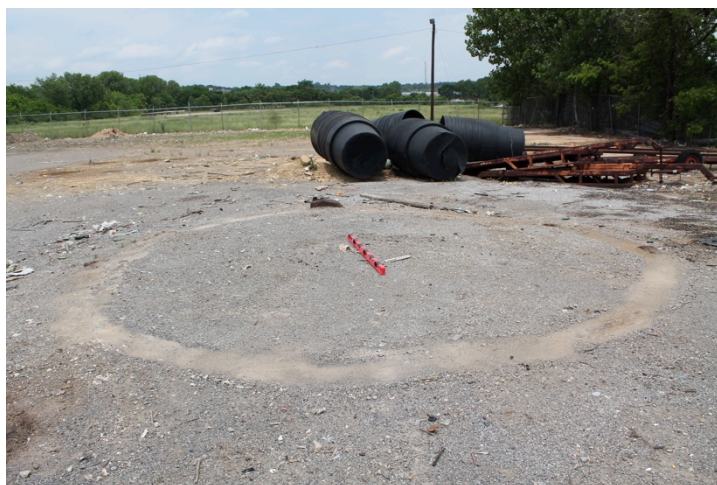
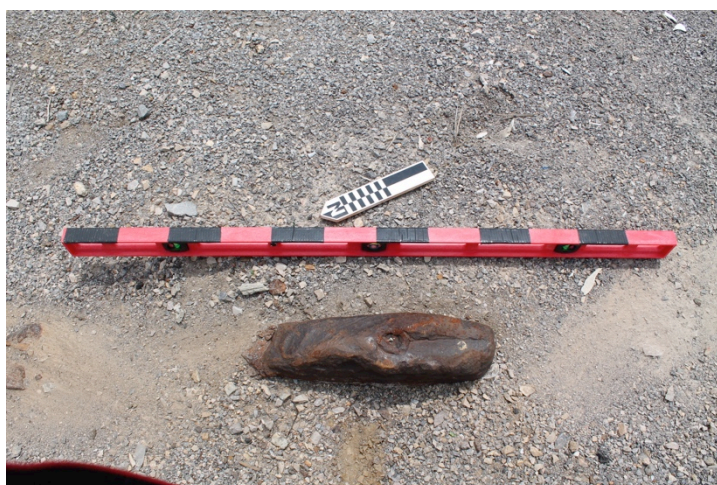
Figure 63. Feature 5, Remains of the No. 4 Furnace.

**Dimensions:** 6.4 m in diameter (at ground surface)

*East View*

*North View*

*Remnant of Furnace Visible at the Surface*

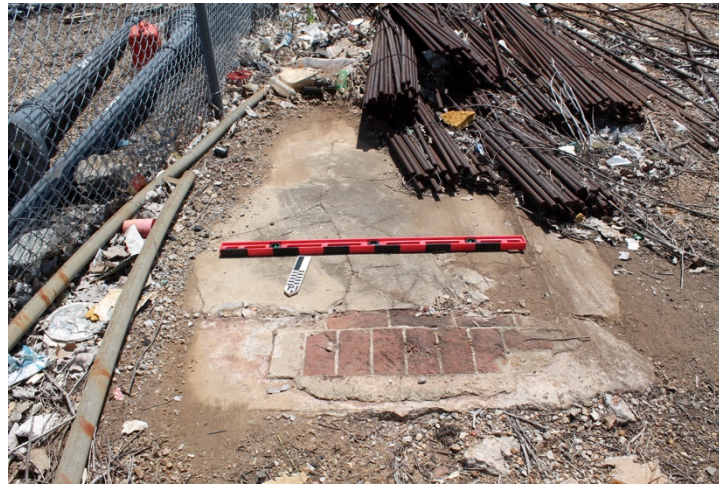
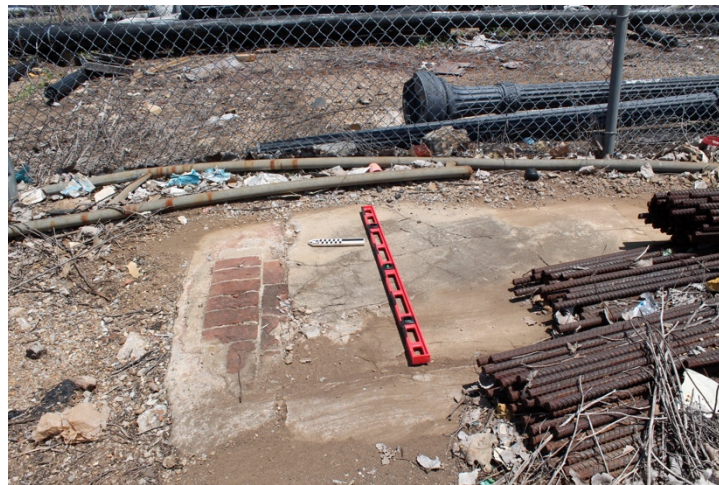
Figure 64. Feature 6, Undetermined Function.

*South-Southeast View*

*East-Northeast View*

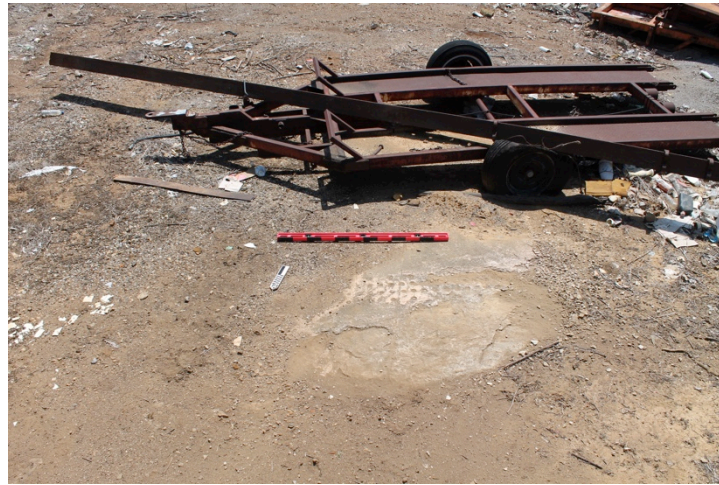
Figure 65. Feature 7, Blast Stove Platform.

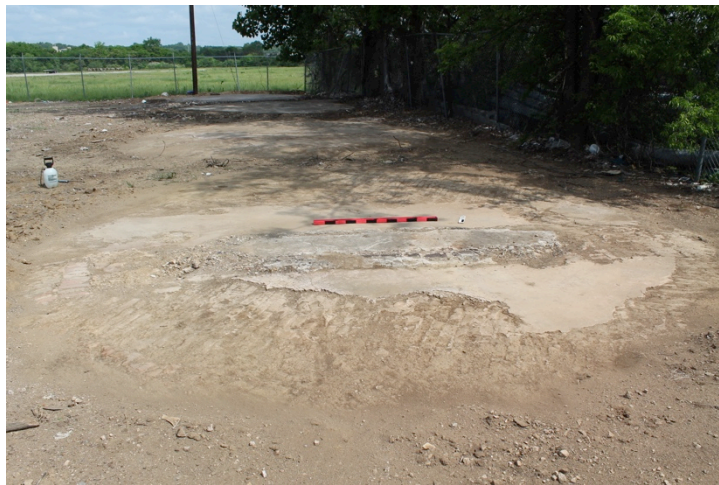
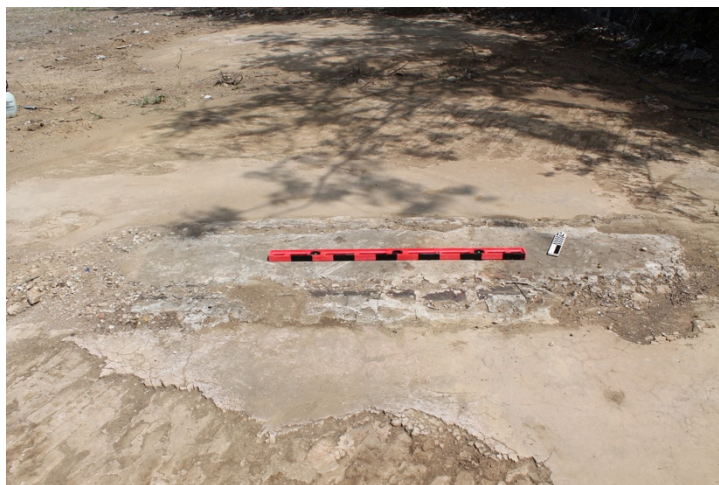
Figure 66. Feature 8, Blast Stove Platform.

**General Description:** At the onset of the fieldwork, this feature was originally identified as two separate features (8 and 9). Upon removing debris from the area and skimming/sweeping a shallow overburden (approximately 1-3 cm of soil and gravel), it was determined that they were part of the same feature; therefore, this is designated as Feature 8, and 9 was discarded. Feature 8 (Figure 66) is a circular, brick and poured concrete foundation that is exposed at the ground surface. The shape and size of the feature is nearly identical to Features 7, 10, 11, and 12. The base of the foundation is made of brick. A thin layer of poured concrete covers the center of the foundation. The poured concrete is chipping away, which makes it difficult to determine if the poured concrete once covered the entire brick foundation. Metal rivets and a long piece of metal are visible beneath the poured concrete, in an area measuring approximately 4.3 m long by 1 m wide, which suggests that something was bolted to the foundation.

*North-Northwest View*

*North-Northwest View with Other Stove Features in Background*

*North-Northwest View of the Center of the Platform Where the Stove was Anchored*

**Function/Historical Context:** Features 7, 8, 10, 11, and 12 are the foundation remains for the blast stoves. Feature 8 is the second stove foundation in a line of five, which were associated with the No. 4 Furnace (Feature 5). Feature 8 appears to be associated with a stove shown on the 1911 Sanborn map, but not on earlier Sanborn maps. It also correlates to a stove shown on the 1951 Sanborn map. The stoves provided a regenerative heat exchange to the furnace. Historic photographs indicate that the early stoves included eight 3-pass Gordon Whitwell Cowper stoves, which had a chimney pipe extending upward from the top of the silo-shaped stove. The 1964 photographs show more modern stoves, consisting of ten 2-pass stoves with side exhaust stacks. Historic photographs also indicate that much of the flue work between the stoves and furnace was above ground; however, it is possible that an underground flue could have extended along the backside (east) of the stoves.

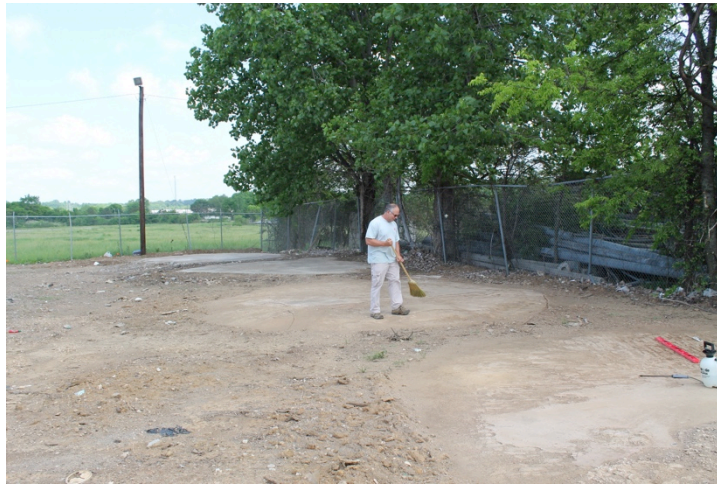
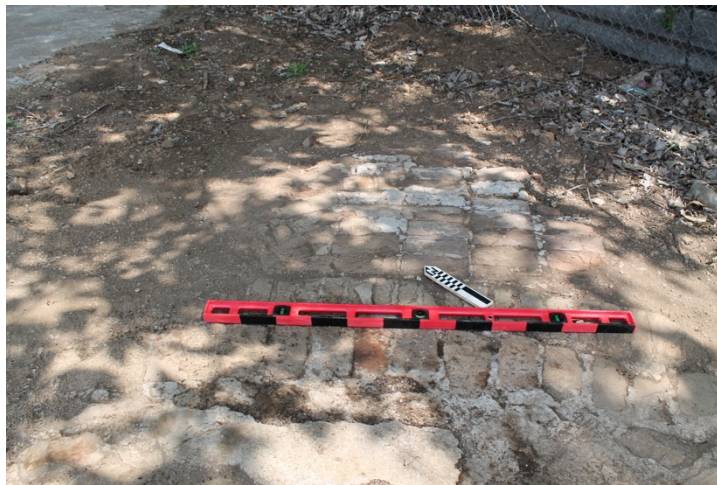
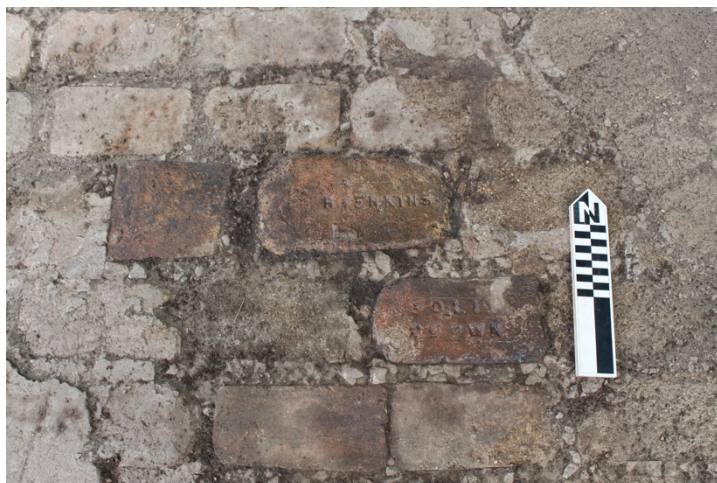
Figure 67. Feature 10, Blast Stove Platform.

**General Description:** Feature 10 (Figure 67) is a circular, brick and poured concrete foundation that is exposed at the ground surface. The shape and size of the feature is nearly identical to Features 7, 8, 11, and 12. The base of the foundation is made of brick. A thin layer of poured concrete covers portions of the foundation's center; however, the poured concrete is chipping away, which makes it difficult to determine if the poured concrete once covered the entire brick foundation. A small, square brick platform is connected to the northeastern edge of the circular feature, which measures approximately 1.6 m wide by 1.55 m long. Some of the Feature 10 bricks have manufacturer stamps. Stamps identified on bricks include: "Imperial Steel," "Solid Crown," and "R. Jenkins," which were brands of fire brick produced by brick factories owned by the Harbinson-Walker Refractories Company that was established in 1902 (Cottrell 2016); and "Ensley" brick, which was locally made by the Ensley Brick Company that was established in Ensley, Alabama in 1898 (Alabama Secretary of State 2016, Entity I.D. Number 739-992).

*Cleaning off the Feature, North-North View*

*Small Brick Platform Attached to the Northern Edge of the Stove Platform*

*Detail of the Stove Platform Brick*

**Function/Historical Context:** Features 7, 8, 10, 11, and 12 are the foundation remains for the blast stoves. Feature 10 is the third stove foundation in a line of five, which were associated with the No. 4 Furnace (Feature 5). Feature 10 does not appear to be associated with any stoves shown on the 1888, 1891, 1902, or 1911 Sanborn maps; however, it is associated with a stove shown on the 1951 Sanborn map. This stove may have been added to the facility before or during the 1919-1924 upgrades. The small, square platform connected to the northeastern edge of the stove platform is likely associated with the stove's exhaust stack. The stoves provided a regenerative heat exchange to the furnace. Historic photographs indicate that the early stoves included eight 3-pass Gordon Whitwell Cowper stoves, which had a chimney pipe extending upward from the top of the silo-shaped stove. The 1964 photographs show more modern stoves, consisting of ten 2-pass stoves with side exhaust stacks. Historic photographs also indicate that much of the flue work between the stoves and furnace was above ground; however, it is possible that an underground flue could have extended along the backside (east) of the stoves.

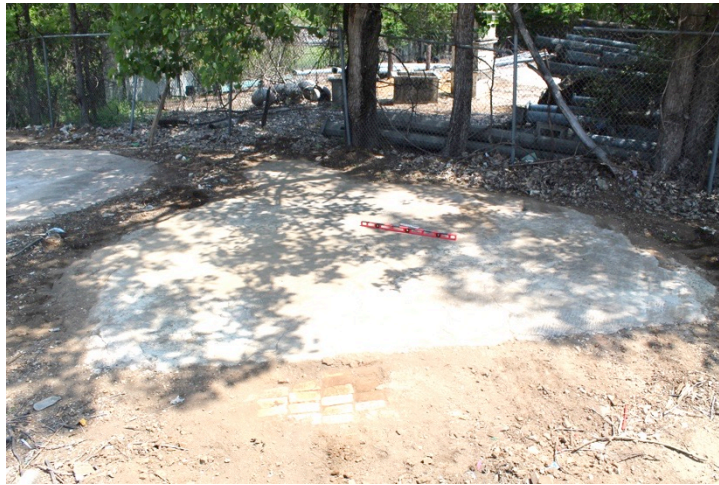
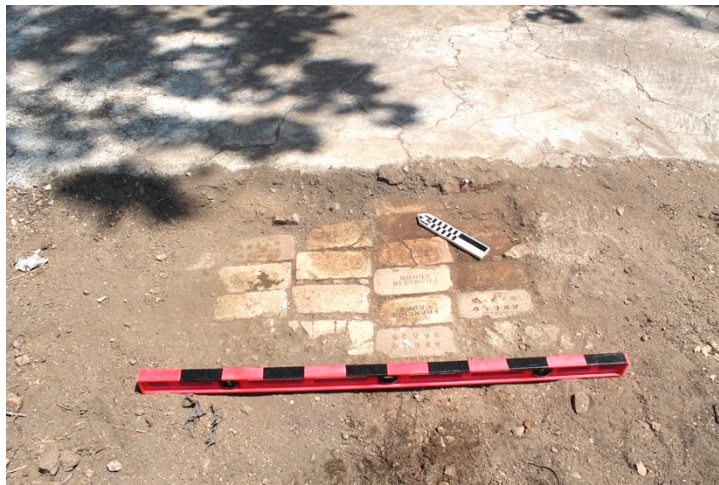
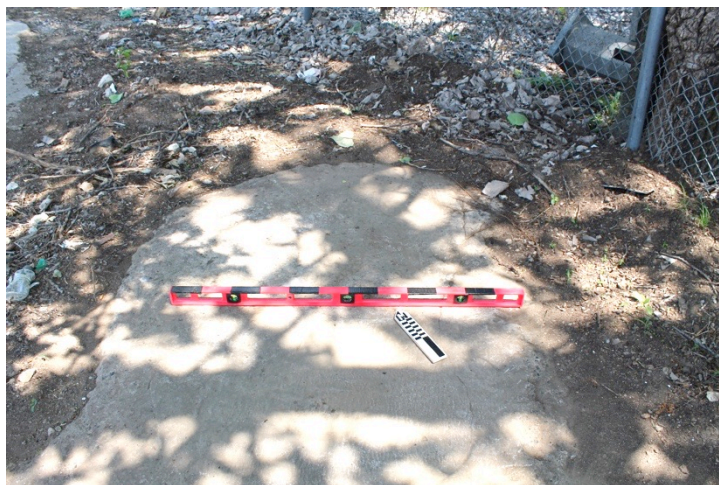
Figure 68. Feature 11, Blast Stove Platform.

**General Description:** Feature 11 (Figure 68) is a circular, brick and poured concrete foundation that is exposed at the ground surface. The shape and size of the feature is nearly identical to Features 7, 8, 10, and 12. The base of the foundation is made of brick, a small area of which is exposed on the southwestern edge of the feature. The majority of the feature is covered in a thin layer of poured concrete. A small, rectangular poured concrete platform is connected to the northeastern edge of the circular feature, which measures approximately 1.5 m wide by 2.0 m long. Some of the Feature 11 bricks have manufacturer stamps. Stamps identified on the bricks include “Franklin Crown” and “Anglo Saxon,” which were brands of fire brick produced by brick factories owned by the Harbinson-Walker Refractories Company that was established in 1902 (Cottrell 2016).

*North-Northeast View*

*Detail of Brick, North-Northeast View*

*Small Concrete Platform Attached to the Northern Edge of the Stove Platform*

**Function/Historical Context:** Features 7, 8, 10, 11, and 12 are the foundation remains for the blast stoves. Feature 11 is the fourth stove foundation in a line of five, which were associated with the No. 4 Furnace (Feature 5). Feature 11 does not appear to be associated with any stoves shown on the 1888, 1891, 1902, or 1911 Sanborn maps; however, it is associated with a stove shown on the 1951 Sanborn map. This stove may have been added to the facility before or during the 1919-1924 upgrades. The small, rectangular platform connected to the northeastern edge of the stove platform is likely associated with the stove’s exhaust stack. The stoves provided a regenerative heat exchange to the furnace. Historic photographs indicate that the early stoves included eight 3-pass Gordon Whitwell Cowper stoves, which had a chimney pipe extending upward from the top of the silo-shaped stove. The 1964 photographs show more modern stoves, consisting of ten 2-pass stoves with side exhaust stacks. Historic photographs also indicate that much of the flue work between the stoves and furnace was above ground; however, it is possible that an underground flue could have extended along the backside (east) of the stoves.

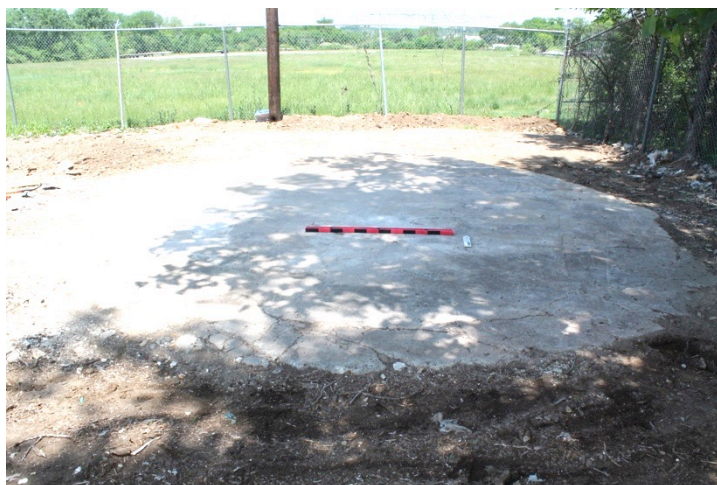
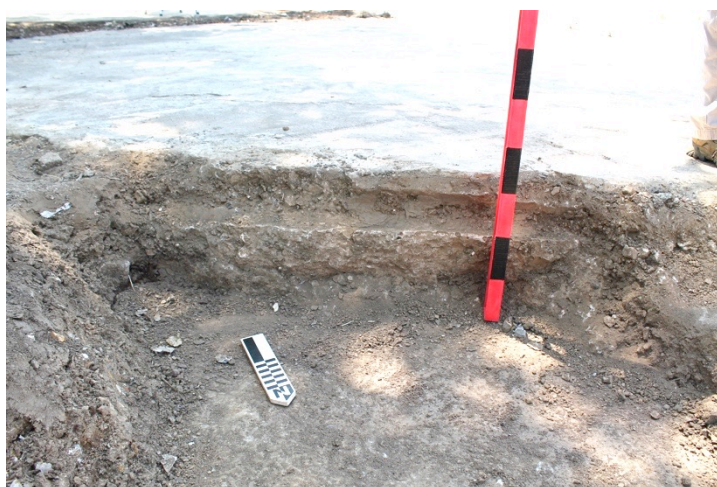
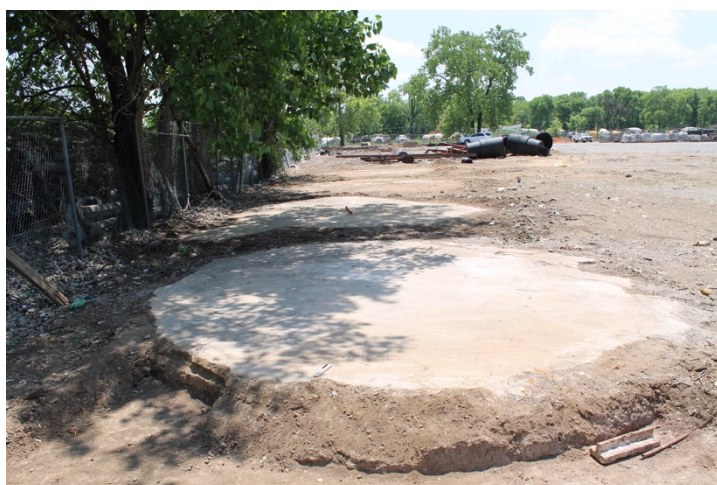
Figure 69. Feature 12, Blast Stove Platform.

**General Description:** Feature 12 (Figure 69) is a circular poured concrete foundation that is exposed at the ground surface. The shape and size of the feature is nearly identical to Features 7, 8, 10, and 11; however, unlike the other circular features, Feature 11 appears to be composed entirely of poured concrete. No underlying brick foundation was identified. Soil on the northern edge of the feature was removed to determine if underlying brick existed, which revealed the poured concrete platform to measure approximately 32 cm in thickness.

*North View*

*Profile of the Concrete Platform, South-Southwest View*

*South-Southeast View of Feature 12 and Other Stove Platforms*

**Function/Historical Context:** Features 7, 8, 10, 11, and 12 are the foundation remains for the blast stoves. Feature 11 is the fifth (northernmost) stove foundation in a line of five, which were associated with the No. 4 Furnace (Feature 5). Feature 11 does not appear to be associated with any stoves shown on the 1888, 1891, 1902, or 1911 Sanborn maps; however, it is associated with a stove shown on the 1951 Sanborn map. It is interesting to note that it is the northernmost stove foundation, and the only one that is constructed solely of poured concrete. This may suggest that this is the latest stove foundation, and may have been added to the facility during or after the 1919-1924 upgrades. The stoves provided a regenerative heat exchange to the furnace. Historic photographs indicate that the early stoves included eight 3-pass Gordon Whitwell Cowper stoves, which had a chimney pipe extending upward from the top of the silo-shaped stove. The 1964 photographs show more modern stoves, consisting of ten 2-pass stoves with side exhaust stacks. Historic photographs also indicate that much of the flue work between the stoves and furnace was above ground; however, it is possible that an underground flue could have extended along the backside (east) of the stoves.

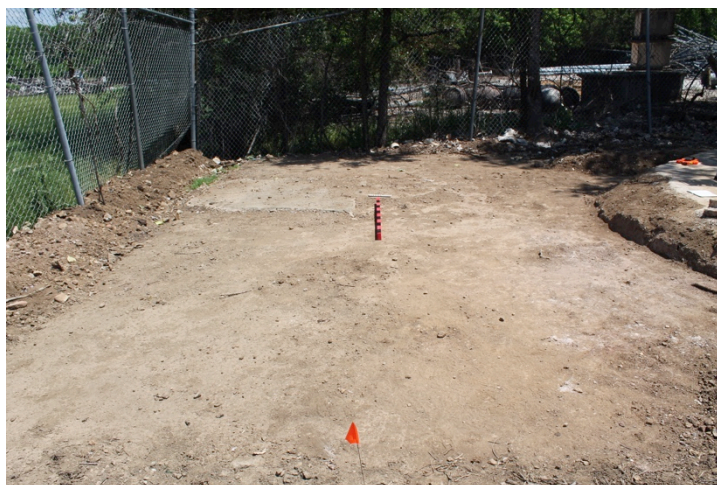
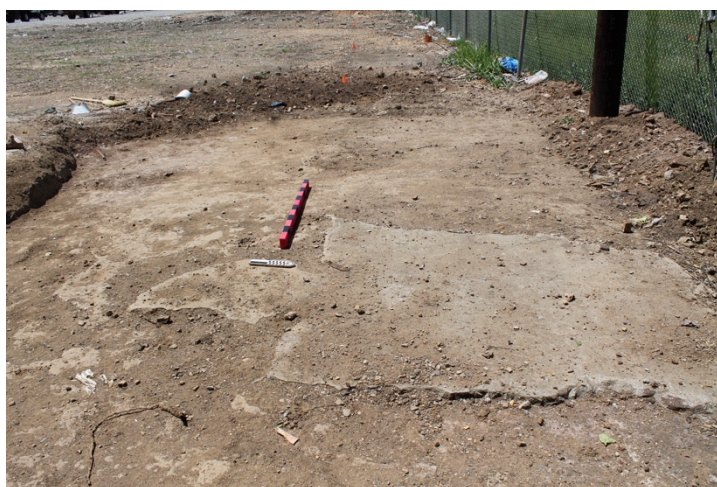
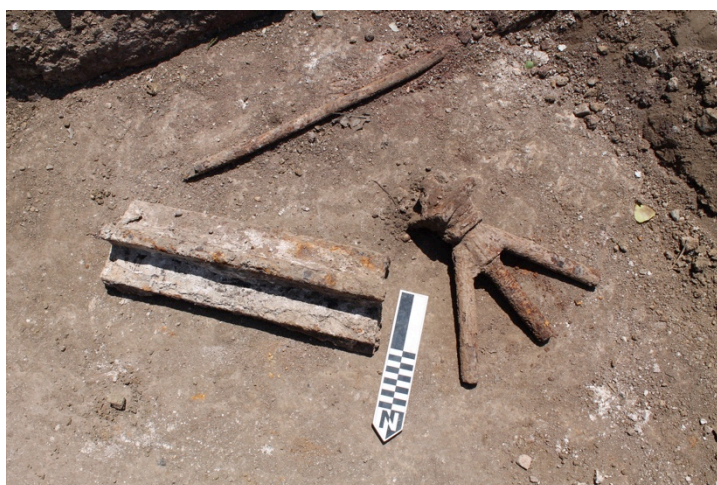
Figure 70. Feature 70, Undetermined Function (Possibly Associated with an Ancillary Building).

**General Description:** Feature 13 (Figure 70) is a rectangular, poured concrete foundation that was partially exposed at the ground surface to the north of Feature 12. Overlying fill was skimmed from the surface to fully expose the feature. The edges and surface of the concrete foundation are very rough, which may be a result of aging and/or their haphazard construction. The northern and eastern edges of the foundation are bordered by fencelines, but their edges were exposed below the fill to make certain that the foundation did not extend further beyond the fences. The southern edge of the feature abuts the northern edge of Feature 12; however, it sits at a slightly lower elevation than the adjacent feature. In fact, the top surface of Feature 13 sits at the same elevation as the bottom of Feature 12, which is 32 cm thick. It is also notable that three metal objects were found in the shallow overburden laying atop the feature, including a narrow metal pipe (<10 cm in diameter) that extended into the surrounding soil, a possible fragment of an industrial rail (<30 cm in length), and an identified object. The later two objects were very heavy, and the pipe was buried and could not be removed; therefore, they were not collected. Photographs were taken of the metal objects (Figure 70). It is undetermined if they are associated with the historical industrial use of the site, or if they are the result of modern trash dumping, which is abundant across the site.

*East View*

*West View*

*Metal Objects Found in the Overburden Laying Atop the Concrete Foundation*

**Function/Historical Context:** The function of Feature 13 is undetermined. It sits on the northern edge of the facility, immediately north of the northernmost stove foundation that likely dates during or after the 1919-1924 upgrades. Feature 13 may date to the same time period. Although small, ancillary buildings are shown in this general area on the 1911 and 1951 Sanborn maps, none of those structures correspond to the size and/or location of this foundation. However, the 1964 flyover photographs (Figures 28-31) of the facility do show a small, ancillary building in this location. It appears that Feature 13 corresponds to that small structure. Regardless, its function is still undetermined.

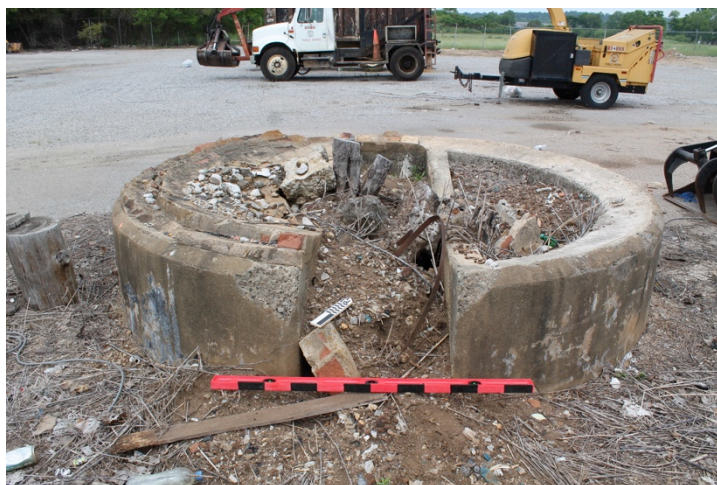
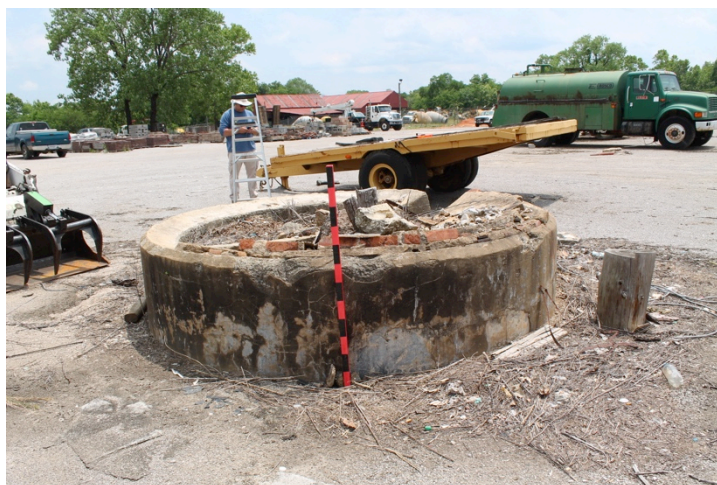
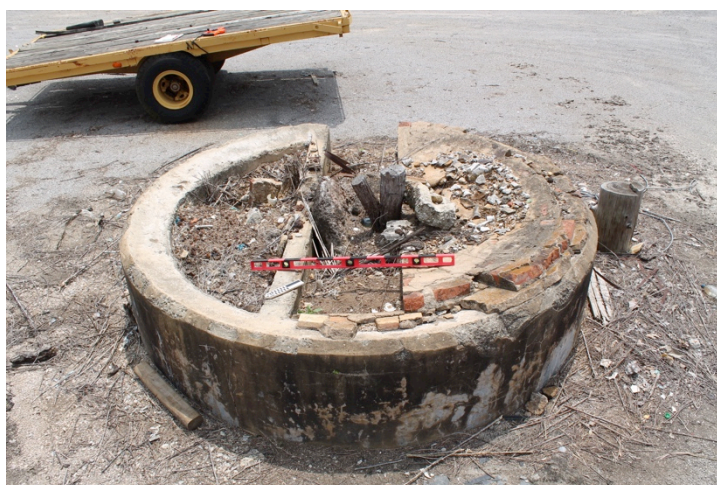
Figure 71. Feature 17, Undetermined Function (Possibly Associated with Pig-Casting Machine Shed).

**General Description:** Feature 14 (Figure 71) is a circular, poured concrete foundation that sits a considerable distance from the other structural features. The feature is located approximately 59 m to the west-southwest of Feature 5 (No. 4 Furnace). The foundation measures 3.2 m in diameter and is 1.0 m in height above the ground surface. The interior of the foundation is segmented into three sections, which are filled with soil and debris. There is an opening into the interior segment of the feature, on the southern side of the foundation, which could have supported something like a drain, pipe, mechanical device, or served some other function. It appears that the poured concrete foundation was once lined with brick on its top, as brick still survives in a portion of the foundation.

*North-Northwest View*

*Southeast View*

*South-Southwest View*

**Function/Historical Context:** Feature 14 sits a considerable distance from the remains of the furnaces, stoves, and other features. It does not correspond to any structures shown on the 1888, 1891, 1911, or 1951 Sanborn maps; however, the 1941 and 1954 aerials, and 1964 flyover photographs indicate that Feature 14 exists in an area that would have housed the automatic pig caster, which was attached to the south side of Casting Shed No. 4. The original facility used the large, sand casting sheds to pour the molten iron into pig molds, which was a laborious and time-consuming process. The facilities were eventually upgraded to utilize a ladle car and automatic pig caster in place of the casting sheds, and were likely installed in the 1930s. The pig-casting machine not only reduced the workforce at the furnaces, but also increased the speed that pigs could be produced. The process would have started with molten iron being poured into a 125-ton ladle machine, which would have been positioned between the casting sheds. Molten iron was poured from the ladle machine into a conveyor belt of individual pig molds. The filled molds would travel up the inclined conveyor belt, while water was sprayed onto the molds to cool and solidify the iron. When the molds reached the top of the incline, the cooled pigs were shaken loose and dumped into waiting railcars sitting below the conveyor belt. Feature 14 appears to have been located halfway along the automatic pig-casting shed, although its function is undetermined. However, it also exists in an area where a small square for a scale is drawn on the 1902 Sanborn map. Based on its shape, it is unlikely to have been associated with the scale.

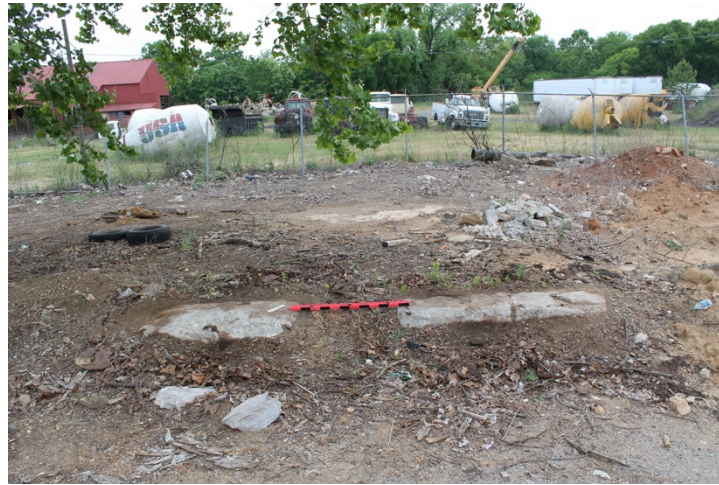
*South View (Stove Platform is Difficult to Discern Beneath the Refuse and Spoil)*

Figure 72. Feature 15, Stove Platform and Adjacent Foundation Stone or Curb Stone.

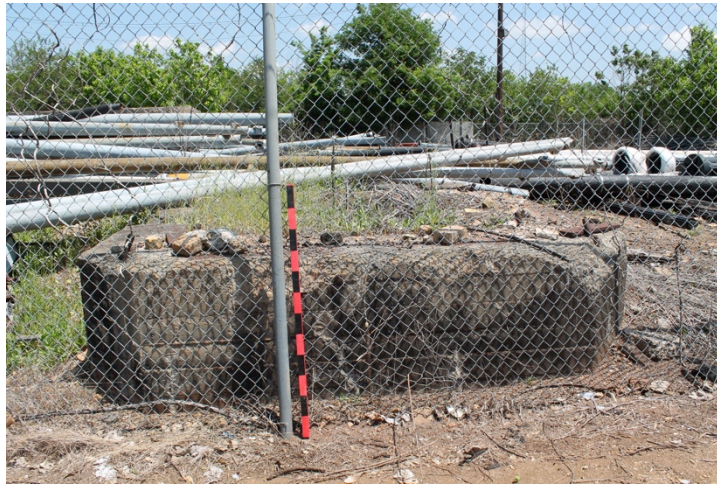
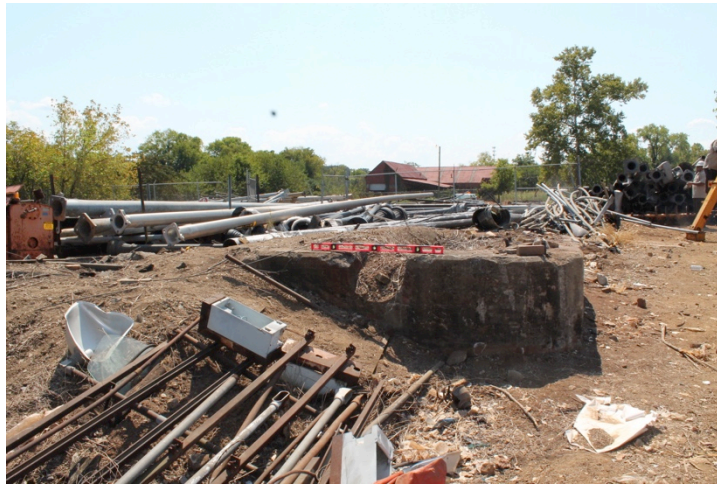
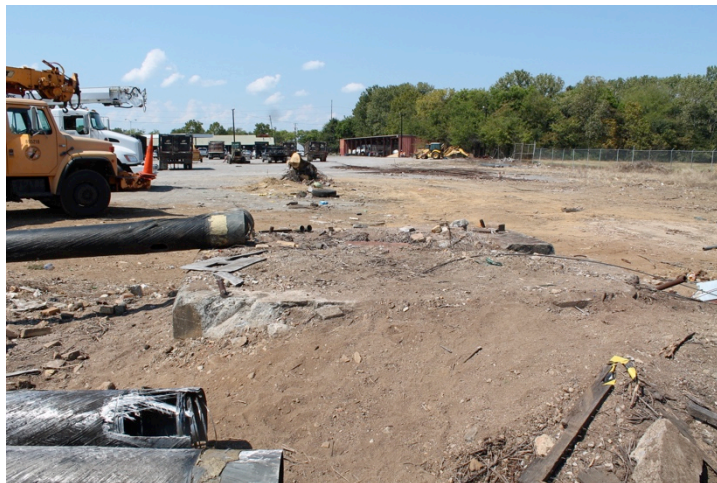
Figure 73. Feature 16, Suspected Foundation for the Gas Cleaning System Equipment. Notice the Amount of Fill on the West Side of the Feature.

**General Description:** Feature 16 (Figure 73) is a square-shaped, poured concrete foundation with beveled edges that sits to the north of Feature 7 (stove platform) and south of Feature 17. This feature is positioned approximately 15 m to the northeast of Feature 5 (No. 4 Furnace). The top of the foundation is covered in fill and debris. At the beginning of fieldwork, the feature was positioned within a fenced storage yard that could not be accessed. The fence surrounding the storage yard was removed within the last two weeks of fieldwork when the light poles were being removed from the project area. The feature was photographed and measured while city crews were removing the light poles. Only the western facade of Feature 16 was fully exposed, while the northern and southern facades were partially covered in fill. The eastern facade was entirely covered in fill. Iron bolts are anchored into the top of the foundation, which indicates that some sort of mechanical equipment was mounted atop of the foundation.

*East-Southeast View Before the Fence was Removed*

*South-Southeast View After the Fence was Removed*

*West-Southwest View*

**Function/Historical Context:** Feature 16 appears to have been a foundation where mechanical equipment was mounted. The feature does not appear to be associated with any structures shown on the 1888, 1891, 1902, or 1911 Sanborn maps; however, it could be associated with an engine hoist depicted on the 1951 Sanborn map, which would have been associated with the nearby skip hoist associated with the No. 4 Furnace (Feature 50). But the 1964 photographs of the facility show the gas cleaning system for the No. 4 Furnace sitting between one of the stoves (Feature 7) and the stock trestle. Based on this photograph, Feature 16 is likely the foundation for the gas cleaning system. The gas cleaning system was connected to the furnace and the stoves, and is part of the regenerative heat exchange to the furnace. As iron ore melted and collected at the base of the furnace, gas would leave through the top of the furnace, flow through the gas cleaning system, and then flow into the stoves.

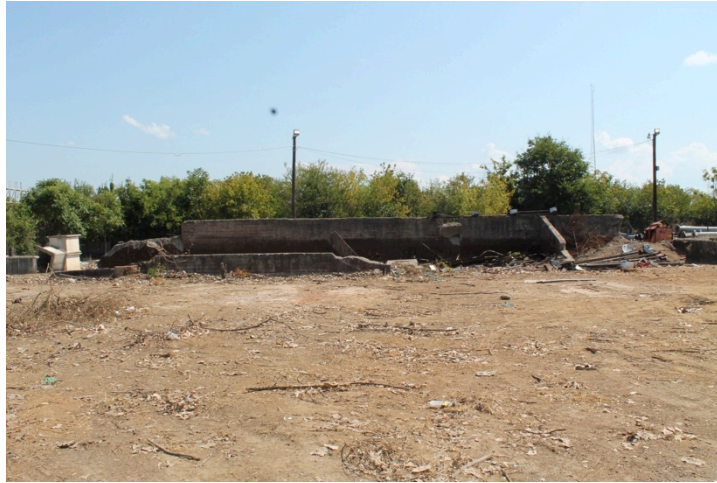
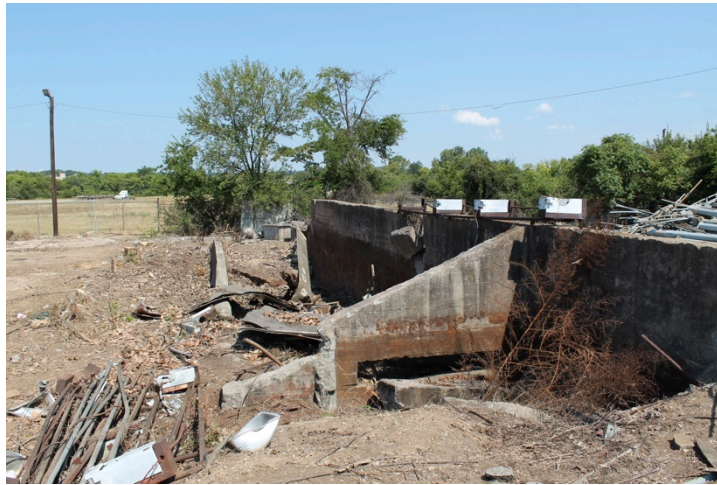
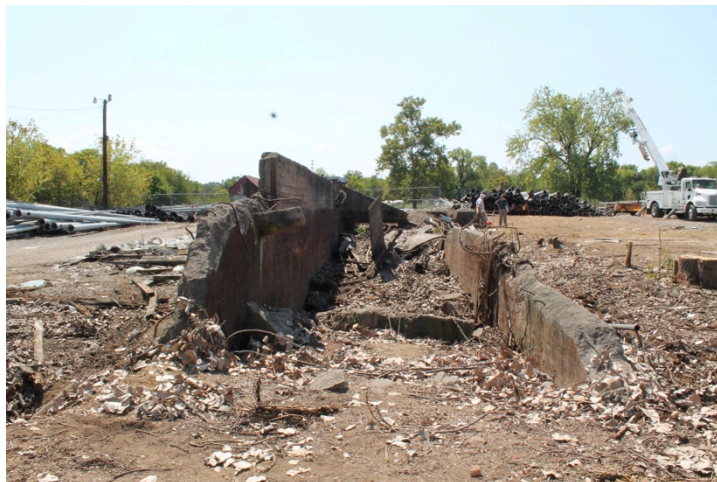
Figure 74. Feature 17, Bin/Walls Bordering the Stock Trestle.

**General Description:** Feature 17 (Figures 74-75) is a long, rectangular-shaped poured concrete foundation. The feature runs parallel to the nearby stove foundations (Features 7, 8, 10, 11, 12), and sits approximately 3.8 m to their east. This feature was originally contained within the fenced storage yard and was barely visible below a massive pile of streetlight poles. A crew from the City of Birmingham removed more than 100 poles from the project area, which were essentially concealing the poured concrete feature. Once the poles were removed from the project during the last two weeks of fieldwork, the feature could be photographed and measured. The walls of the poured concrete feature had been partially removed when the facility was dismantled in the 1960s. While the feature was originally thought to include two separate walls, removing the light poles revealed that it is part of one large feature.

*East View Towards the Western Facade*

*North View from the Southwestern Edge of the Feature*

*South-Southeast View from the Northern Edge of the Feature*

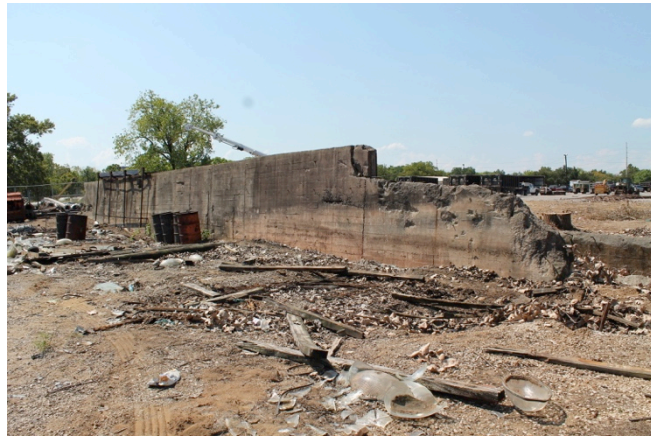
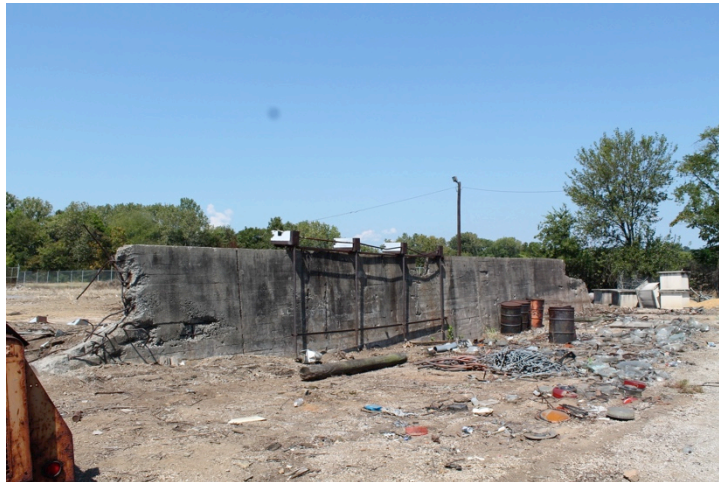
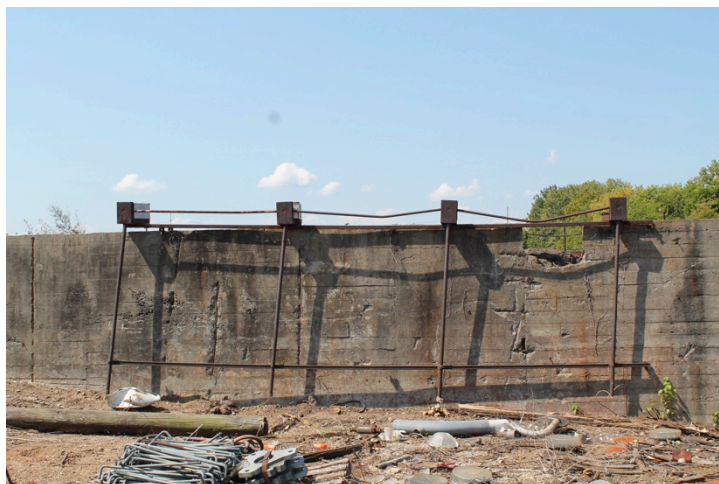
Figure 75. Feature 17, Bin/Walls Bordering the Stock Trestle.

*South View of the Eastern Wall from the Northwestern Edge of the Feature*

*North View of the Eastern Wall from the Southwestern Edge of the Feature*

*West View of Lighting Equipment Hanging on the Eastern Wall*

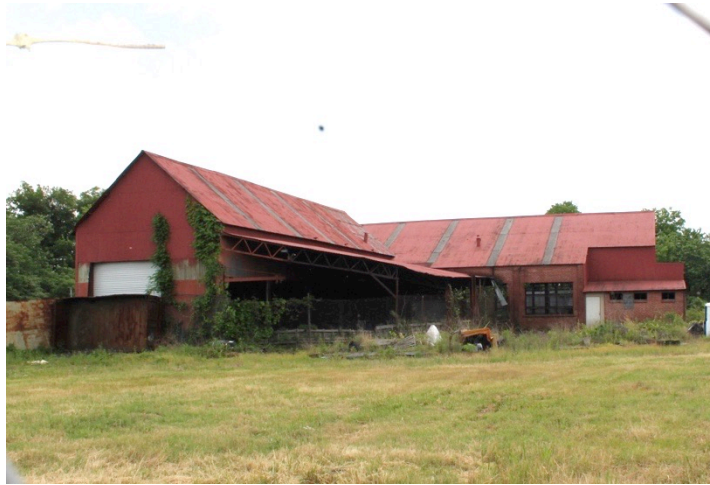
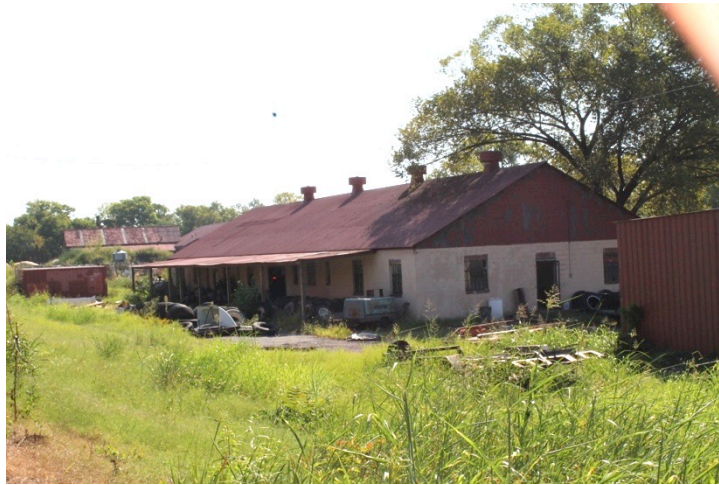
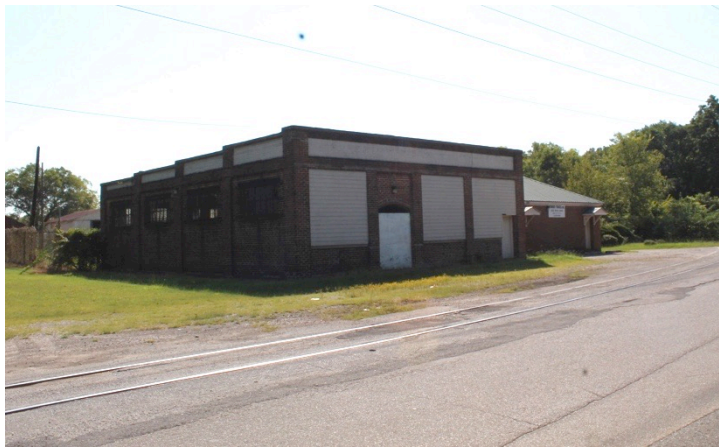
Figure 76. Historic Standing Structures in the APE.

The machine and carpenter shop building (Figure 76) is a large, L-shaped, metal-clad warehouse that was previously recorded by Gregory Jeane (Architectural Historian) in 2005 during a Phase I historic structures assessment of the Finley Boulevard Extension project (Jeane 2006). The structure is shown on the 1941 and 1951 aerials, as well as the 1951 Sanborn map. It is also shown on the 1902 and 1911 Sanborn maps, although it does not correlate in size; however, this may be a problem with the scale of the Sanborn maps (several of the auxiliary buildings do not appear accurate in scale). The structure is one of the few intact remnants of the old furnace site, and appears to date back to the early history of the site. The structure is in fairly good condition considering its age, and it still retains its historic fabric; however, its setting is no longer intact. The machine and carpenter shop building is considered eligible for the NRHP under Criterion A, its association with the SSSIC North Birmingham furnace, which made an important contribution to Birmingham's iron industry. The structure is positioned approximately 120 m (393.7 ft) to the south of the proposed ROW. The ALDOT has determined that the undertaking will have no effect on the historic structure, and the SHPO has concurred with those findings.

The office/storeroom/laboratory (Figure 76) also exists on the adjacent property. The structure is first shown on the 1951 Sanborn map, which denotes its multifunction and construction date of 1950. The structure is a long, one-story, side-gabled concrete block building with a metal roof, four steel cupola ventilators, and a shed metal roof on one side. There appear to be entrances at the center of each façade and steel-barred windows line each façade. The historic fabric of the exterior appears to be fairly well intact. With a construction date of 1950, the use of this structure by the SSSIC would have been very brief (only eight years); however, it does represent one of the final

*Old SSSIC Machine and Carpentry Shop, South View*

*Old SSSIC Storeroom/Office/Laboratory, East-Southeast View*

*Old SSSIC Commissary on 27<sup>th</sup> Street North, Southeast View*

One other historic structure sits on the western edge of this property, but is outside of the fenced compound. The address of the structure is 2400 27<sup>th</sup> Street North, which is just south of the entrance road to the Birmingham Sanitation Department property. The one-story, brick structure (Figure 76) is the old company store for the SSSIC. The store is first shown on the 1941 aerial photograph. The 1951 Sanborn map denotes it as a store. *The EDR-City Directory Abstract* (EDR 2016) shows that the SSSIC Commissary occupied this address in 1925 and 1930; therefore, the commissary dates to at least the 1920s, if not earlier. Although the structure is in good condition, its historic fabric has been modified. Siding has been placed over portions of the front façade (covering the windows), the front entry way is boarded with plywood, a smaller door has been added to the side of the front façade, and a modern addition has been attached to the south façade of the structure. Based on these non-historic modifications, the structure is not considered eligible for NRHP nomination. The commissary exists approximately 120 m (393.7 ft) to the south of the proposed ROW. The undertaking will have no effect on the structure.

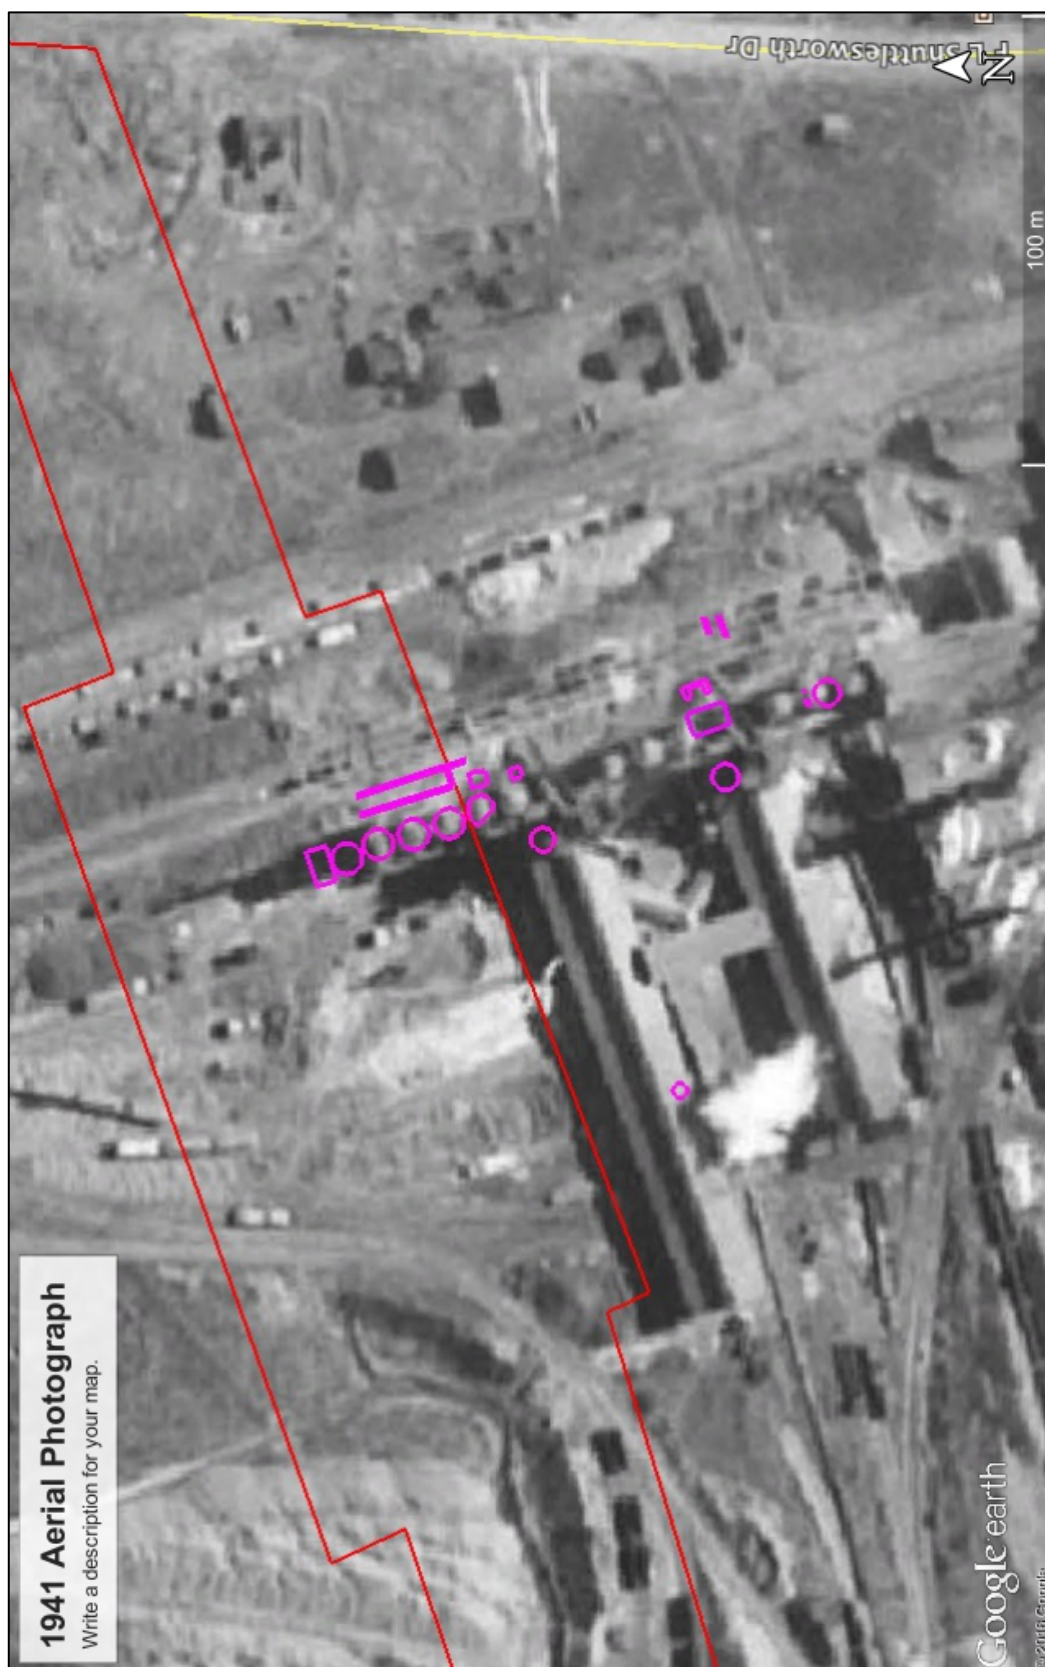
Figure 78. Project Corridor and Features Shown on the 1941 Aerial Photograph Overlay.

these aerial photographs, it is evident that the majority of the SSSIC North Birmingham facility existed outside and south of the project ROW. The only features present within the ROW included the northern bank of stoves associated with the No. 4 Furnace, the northern portion of the stock trestle and stock bins, as well as a few minor auxiliary structures. The majority of the ROW was occupied by the stockyards, containing slag or spoil piles and railroad tracks. All of the major facilities, including the furnaces, casting sheds, pig-machine casting shed, ladle shed, engine house, powerhouse, pump house, ovens (boilers) and machine shop, were positioned outside of the ROW. The casting sheds are very prominent features at the site. Casting Shed No. 3 measured approximately 91.4 m (300 ft) long by 15.2 m (50 ft) wide, and Casting Shed No. 4 measured approximately 113.4 m (370 ft) long by 15.2 m (50 ft) wide. The facility also had two parallel stock trestles that measured approximately 131 m (430 ft in) length. The stock trestles appear to have concrete stock bins below the trestle (represented by the dark, linear shadow), like those that survive at the Sloss Furnaces NHL. We suspect that a stock tunnel would have existed below the stock bins, like the one surviving at Sloss Furnaces NHL. The 1941 and 1956 aerials indicate that the stock bins and the possible stock tunnel were restricted to the area that is now occupied owned by the City of Birmingham. The shadow that represents the stock bins does not extend into the area that is now occupied by the grassed field, which appears to explain why the GPR did not identify any anomalies related to the stock bins in the field.

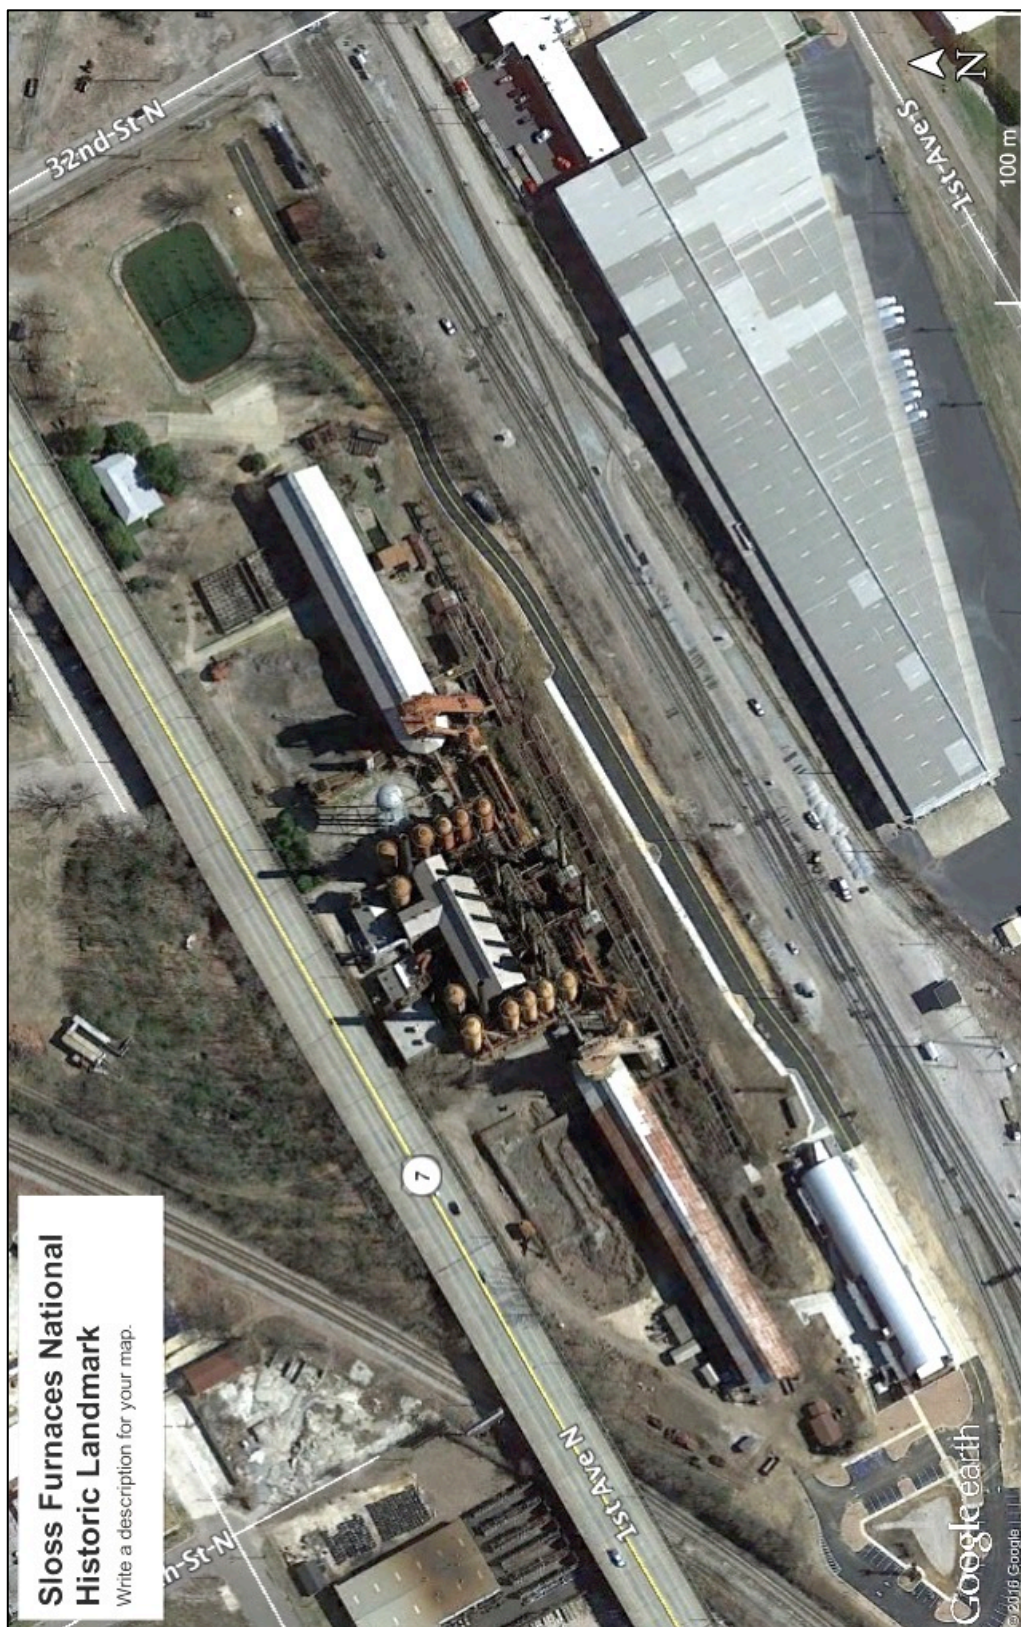
Figure 84. A Modern Aerial Photograph Showing the Sloss Furnaces NHL Site. Unlike the North Birmingham Furnaces, the Casting Sheds at Sloss Furnaces Parallel the Stock Trestle.
