## Phase II Archaeological Testing and Historical Research for the SSSIC North Birmingham Furnaces Site (1Je808), Jefferson County, Alabama ALDOT Project HPP-1602(510) Jefferson County

by  
Catherine C. Meyer

November 9, 2016

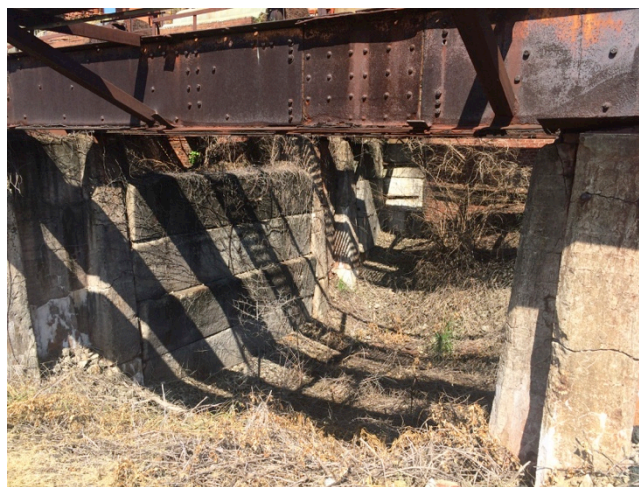
Figure 88. Stock Trestle and Stock Bins at Sloss Furnaces.

*Stock Bins Beneath the Stock Trestle*

*Stock Bin*

Due to logistics, the area where the stock trestle, stock bins, and stock tunnels should exist could not be covered by the GPR survey. This area was filled with soil and gravel when the City acquired the property in the early 1980s. It is likely that these features remain intact, or partially intact, beneath the surface of the City's storage yard. In fact, the ground surface within Feature 17 and on its east side is loose, and small holes are abundant. One larger hole was noted within the project ROW where a concrete beam could be seen (Figure 90), which may be associated with the stock trestle and/or a stock bin. Figure 58 shows the corridor where these remains may exist. This is something that the engineering and construction companies working on this project need to know before they begin construction. Even if the stock bins and stock tunnels still exist here, they should be similar in construction to the ones that exist at the Sloss Furnaces NHL site (Figures 88-89); however, their integrity almost certainly could not compare.

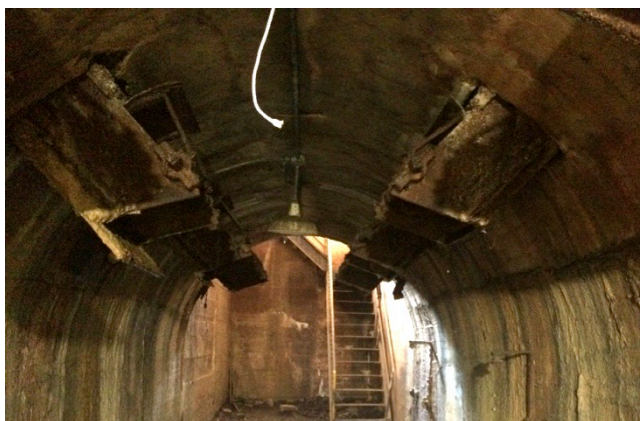
Figure 89. Stock Tunnel at Sloss Furnaces.

*Scale Car in the Stock Tunnel*

*Chutes in the Tunnel Where Material from the Stock Bins Would Slide into the Scale Car*

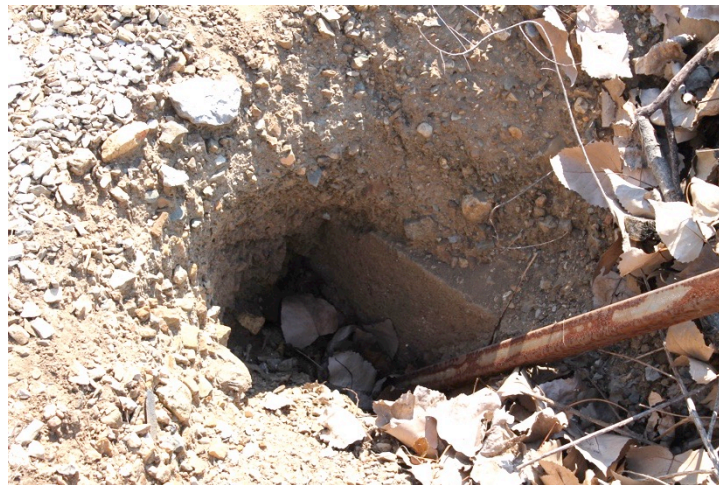
Figure 90. Hole in the Project ROW Where Concrete Structural Remains are Visible Beneath the Fill. These May be Associated with the Stock Trestle and/or Stock Bins.
